Fannin Elementary

General comments, campus capacity, and student demographics

1.0 School Site

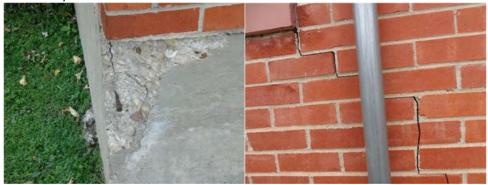
- Southwest corner of cafeteria; some cracks at northwest of Main Building (3 locations).

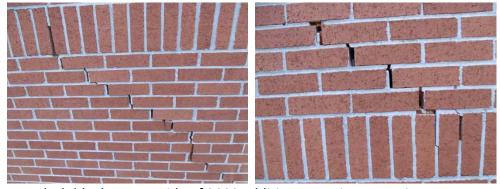
- Cracks at northeast of 2000 addition - no erosion.

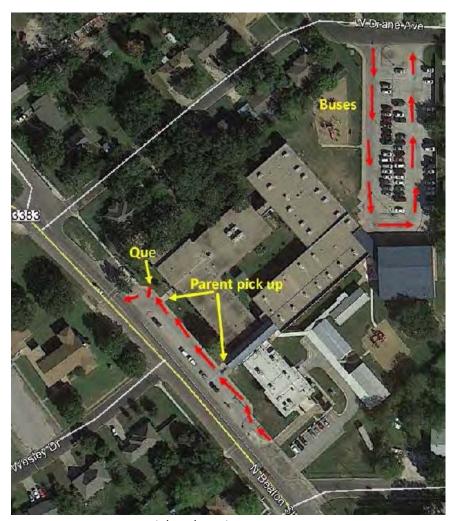
- No canopy at parent pickup location on West.
- Parents pick up on the west side from the entrance near the main office and the hall near the library. There is only enough space for 13 vehicles to stack off of the right- ofway. Cars will stack for over 500 feet beyond the fire station on N Beaton Street across W College Ave.
- Buses pickup on the northeast side.
