Drane Intermediate

General comments, campus capacity, and student demographics:

The Drane Intermediate campus was originally constructed in 1923. The campus is comprised of 91,700 square feet and rests on approximately 7.2 acres. There are currently 414 students enrolled, 6th grade only, and 55 staff. The buildings are generally in good condition, but due to their age there are pressing maintenance and repair issues that need to be addressed.

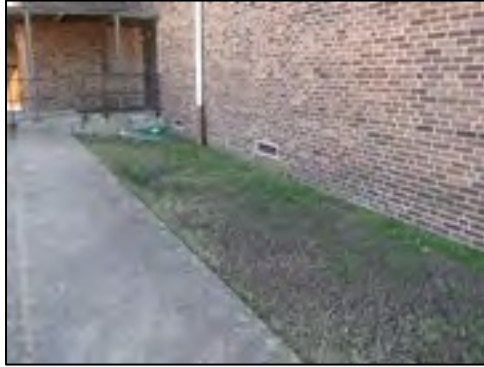
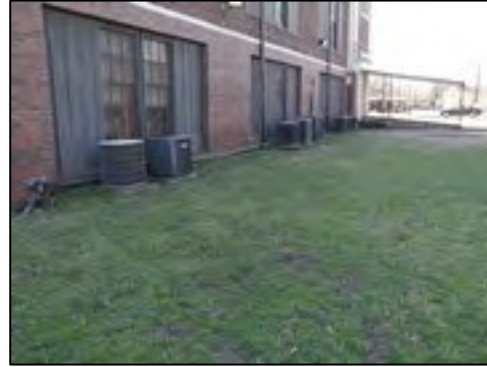
- Ground slopes to building in several areas, storm drain may be clogged.

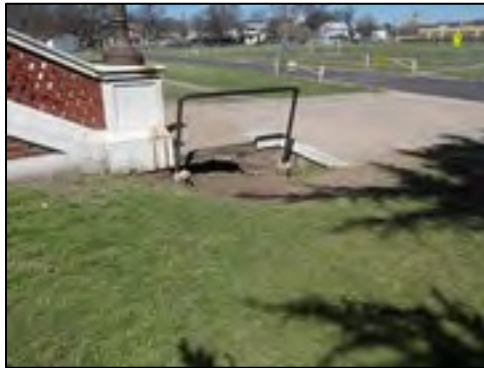
- Erosion along sidewalk.

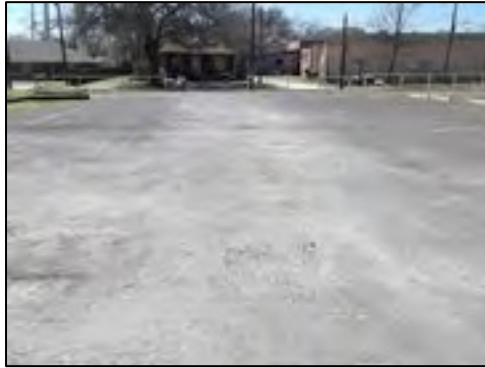
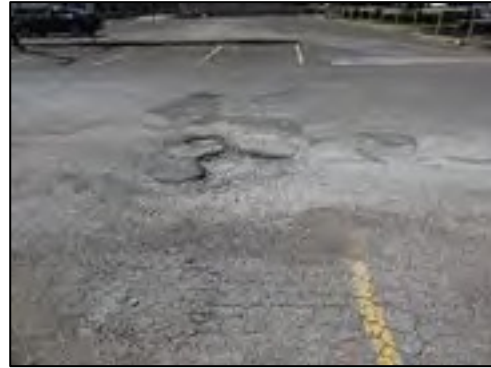
- Asphalt surfaces are in poor condition; due to conditions, seal coating the asphalt would be a poor investment. Recommend rebuilding the parking areas within the next 2 years.

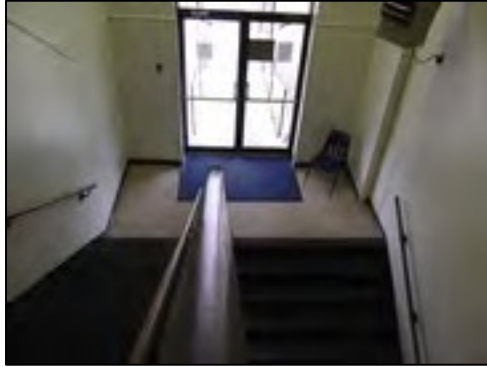
- Many doors have knobs in lieu of lever hardware in all buildings.
- No ADA restrooms provided for staff; no sinks in student restrooms are completely ADA accessible.
- Rear bar needed in ADA stall of girls' restroom on A Floor.
- Exterior ramp leads to door entry that is not accessible due to interior steps.

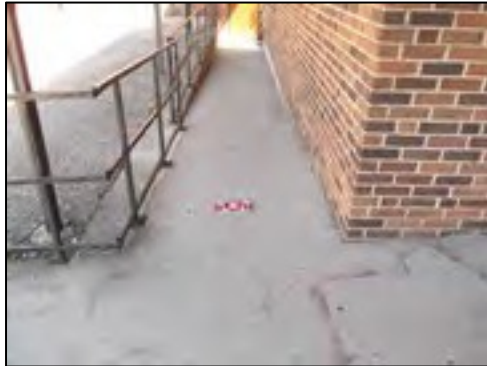
- Side walk cross slope is approximately 8%, 2% maximum needed.

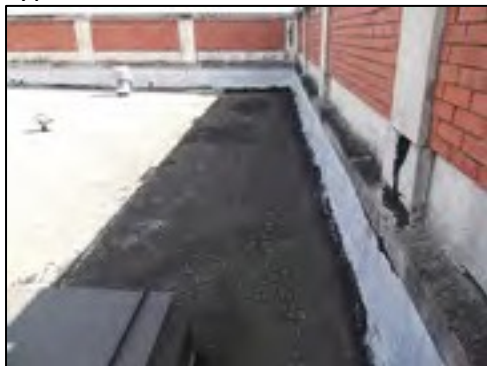
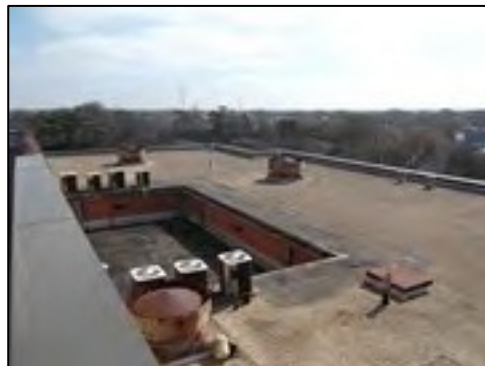
- Roofs on Main building and Cottage are built-up gravel; the Gym roof is built-up gravel and elastomeric roofing. The roofs are 20+ years old and are in fair condition; the roofs have reached the end of their expected life cycle and replacement should be budgeted for in the next five years.
- Typical roof condition.

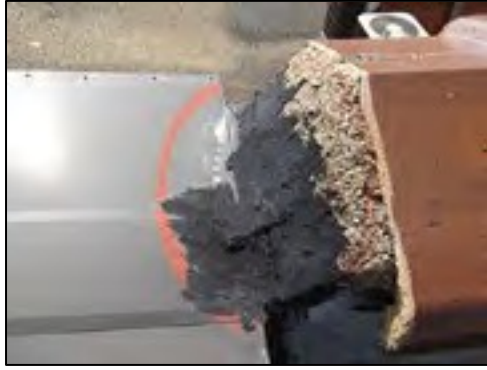
- Mastic is cracked where old roof cap ties into new roof cap.

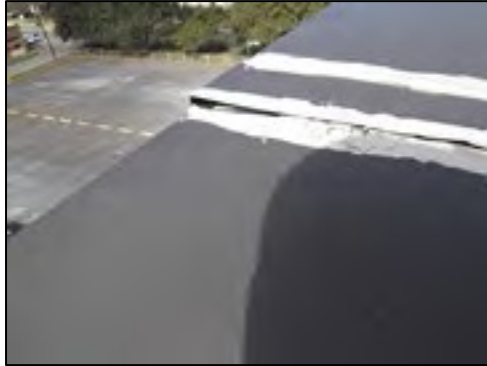
- Gap in parapet wall cap.

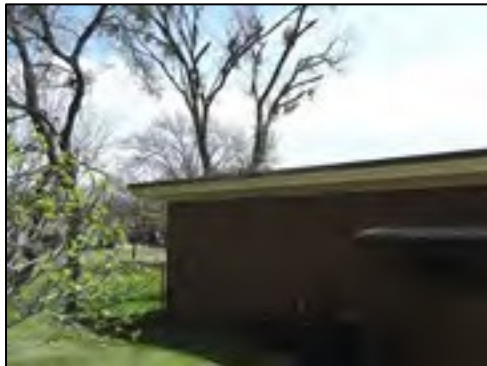
- Trees growing over and against roof lines of Cottage should be trimmed at least 6 feet from the building.

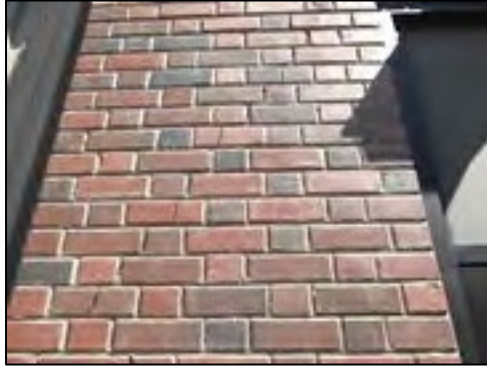
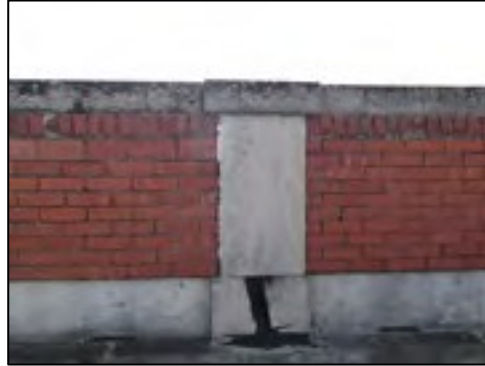
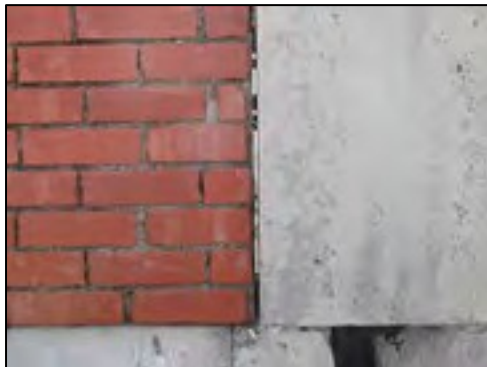
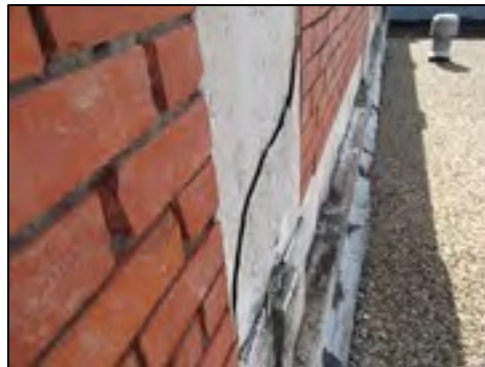
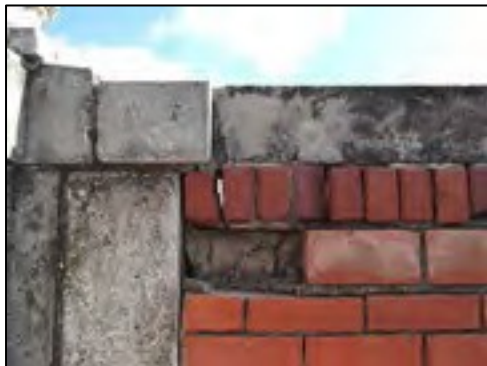
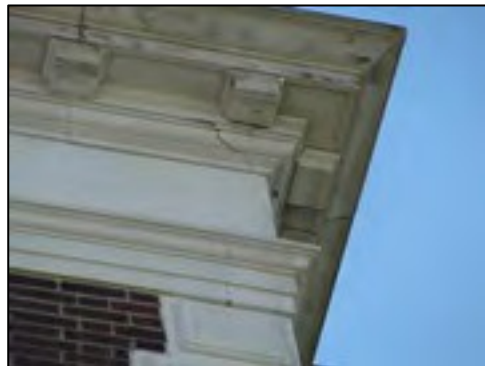
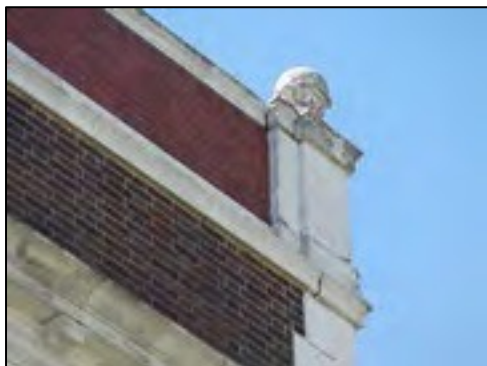
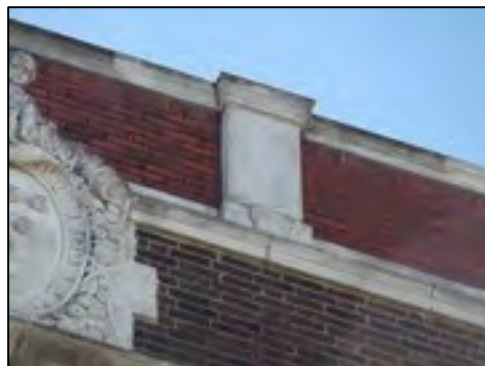
- Brick cracks, mortar failure, and cracks in stonework were observed in several areas. These do not appear significant or to be increasing at this time, however larger cracks should be promptly and properly repaired to prevent excess moisture penetration through the walls. The cracks should be monitored and addressed immediately if movement begins to occur.

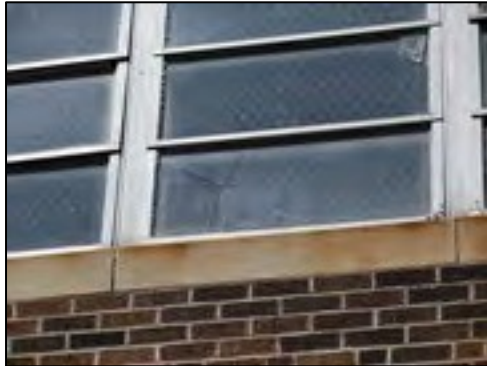
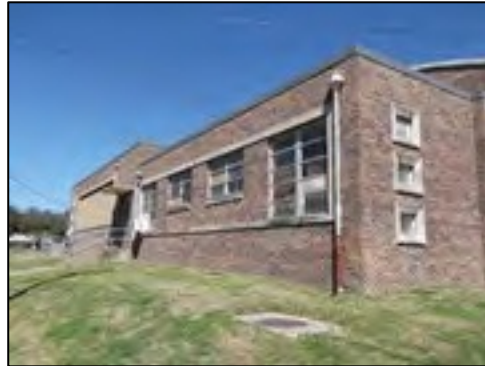
- Windows in all buildings except north side of Main building are inefficient single pane and caulk and glaze is failing. Building expansion joint caulk is failing or beginning to fail at all buildings.
- Broken window glass at several locations.

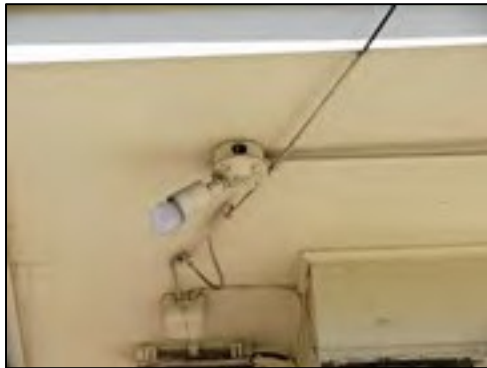
- In many classrooms extension cords are being used for permanent power connections.
- Exposed exterior data cable should be placed inside conduit for better protection.
- Survey reported breakers tripping in Gym and teachers' lounge.
- Missing knock-out plug in electrical box.

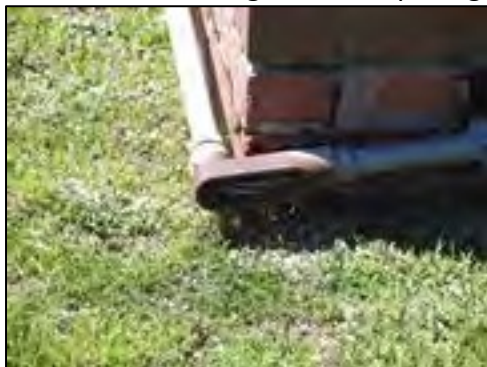
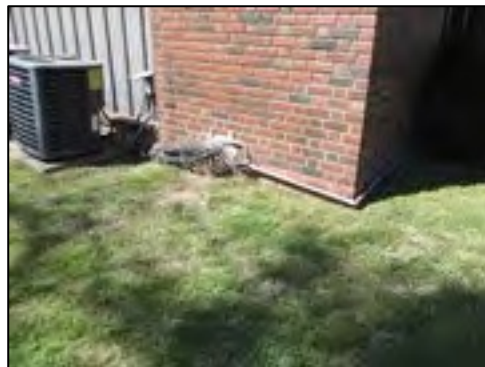
- Conduit has missing covers, exposing the electrical wires.

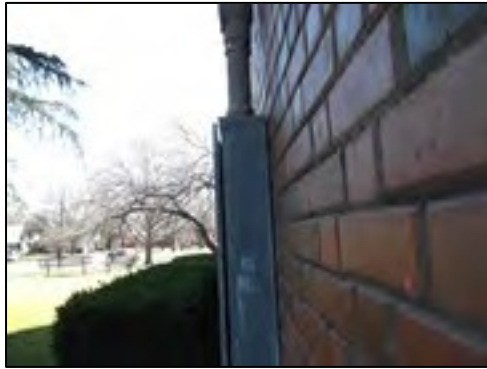
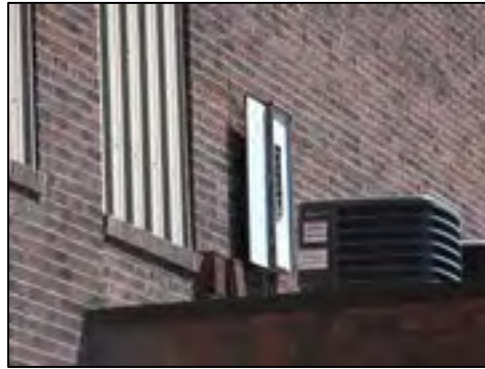
- Open electrical panels on building and on roof.

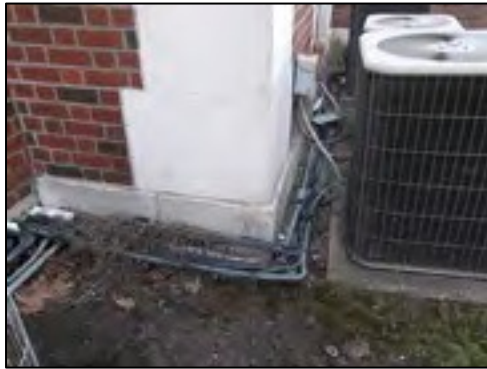
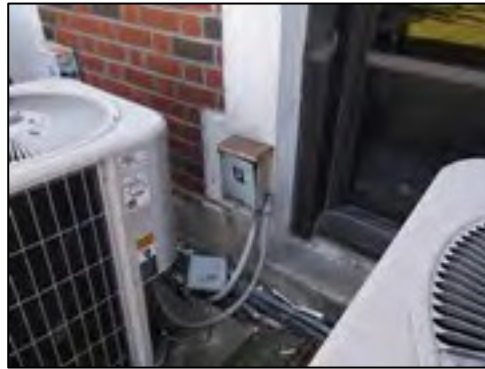
- EMT conduit on or close to the ground (not rated for contact); also open disconnect for AC cover is missing and inside panel is bent.

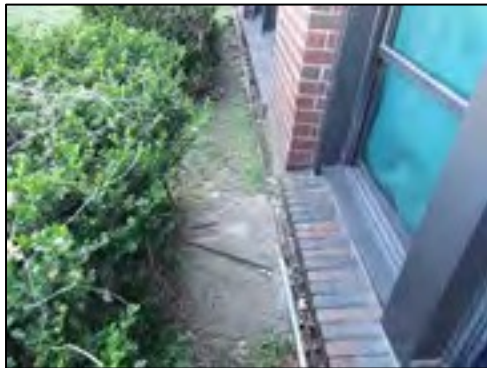
- EMT conduit in contact and supported by concrete.

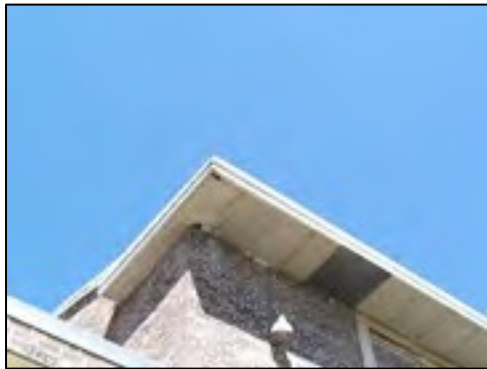
- Most exterior painted finishes at all buildings are in fair-to-poor condition and are in need of repair and repainting.
- Holes in Gym soffit; soffit panels may contain asbestos.

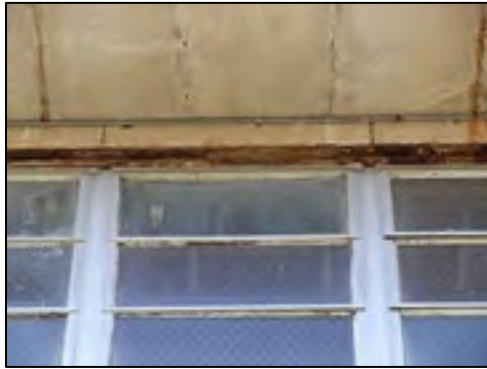
- Lentil rusted above window frames.

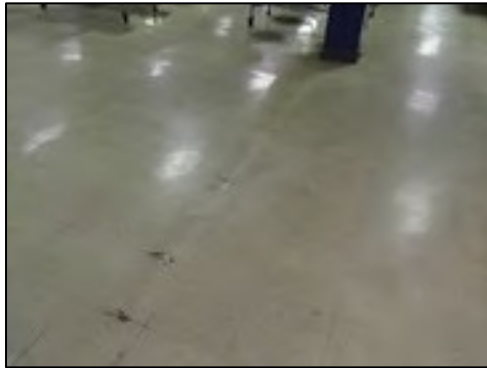
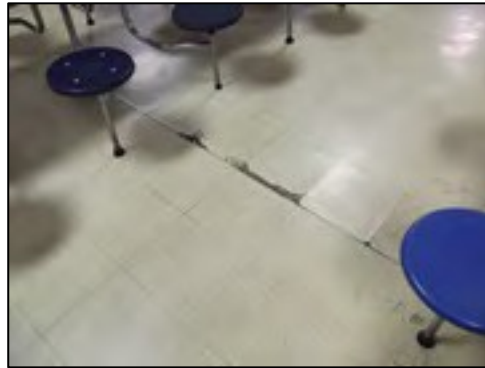
- Carpeting in Main Building is in fair condition; carpet should be replaced within the next 5 years. When the existing carpet is replaced, it should be replaced with carpet tiles to allow small stained or damaged areas to be replaced without replacing entire areas.
- VCT floor tile damaged in cafeteria, may be some cracks/movement in foundation.

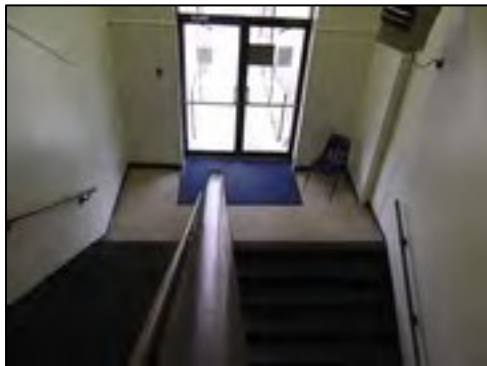
- Damaged floor tile on stair landing.

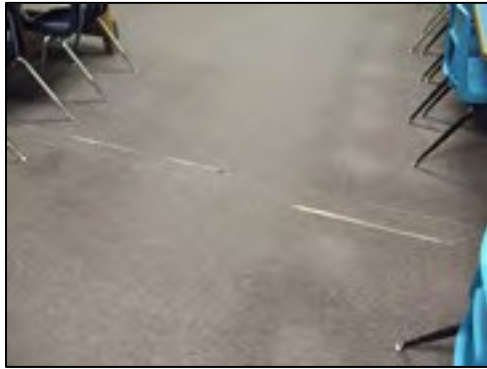
- Carpet seams in room C111.

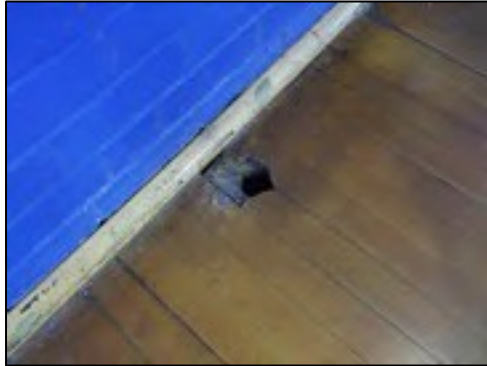
- Hole in gym floor.

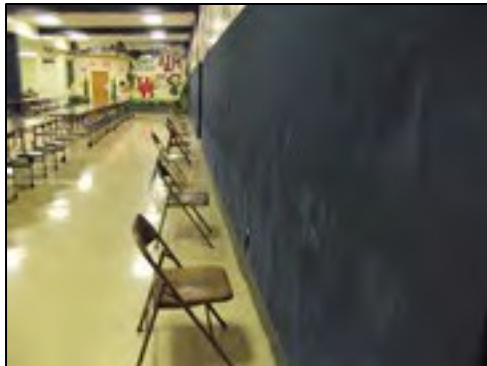
- Interior painted surfaces are in fair-to-poor condition in all buildings; interior surfaces should be repainted in the next 3 years.
- 2'x4' ceiling tile in the Main Building and Cottage is in fair-to-poor condition and should be replaced within the next 5 years.
- Carpeted wall sections in cafeteria are ripped and the sheetrock subsurface is damaged.

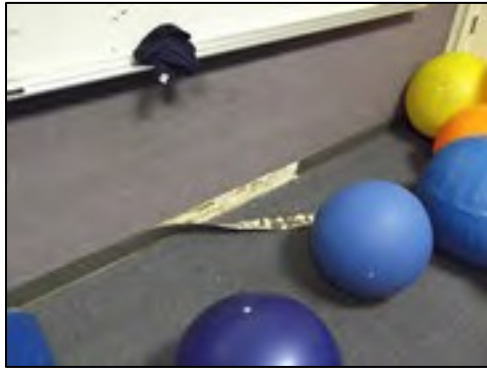
- Base board detaching from wall in room A101.

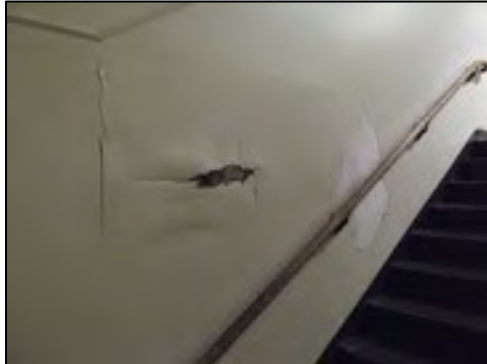
- Plywood wall delaminating east stairwell between floors B and C.

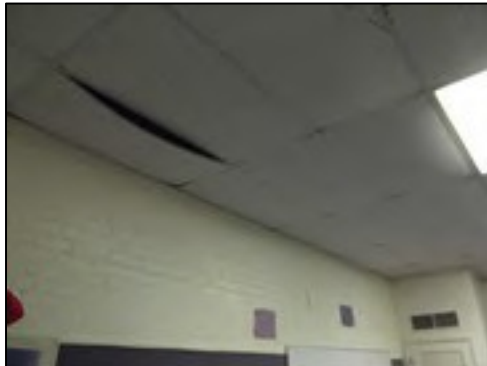
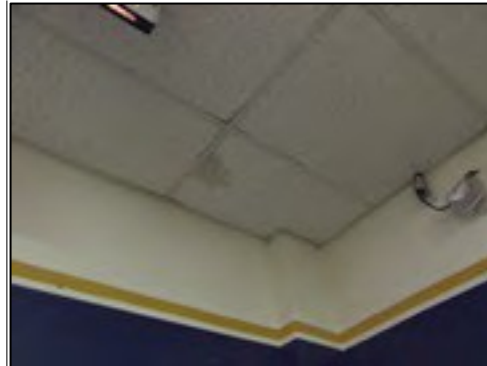
- Ceiling tiles sagging and drooping, and ceiling tile stains.

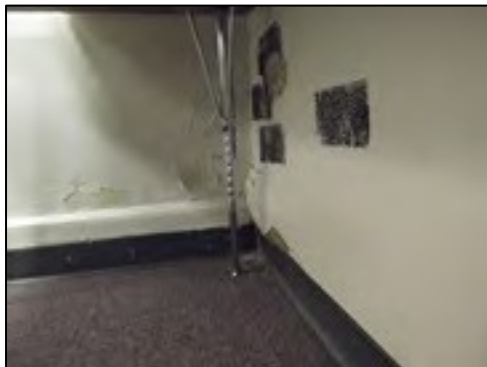
- Wall pushing into classroom A106.

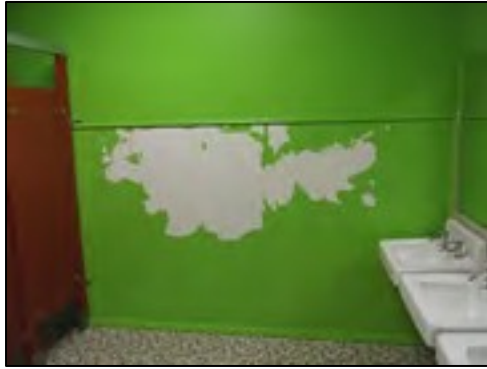
- Paint flaking in girls' restroom.

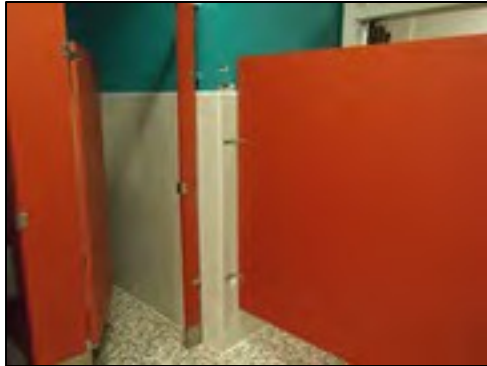
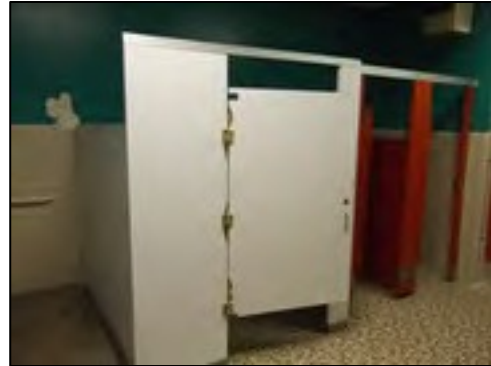
- Boys' restroom Hall B has damaged wall and stall door.

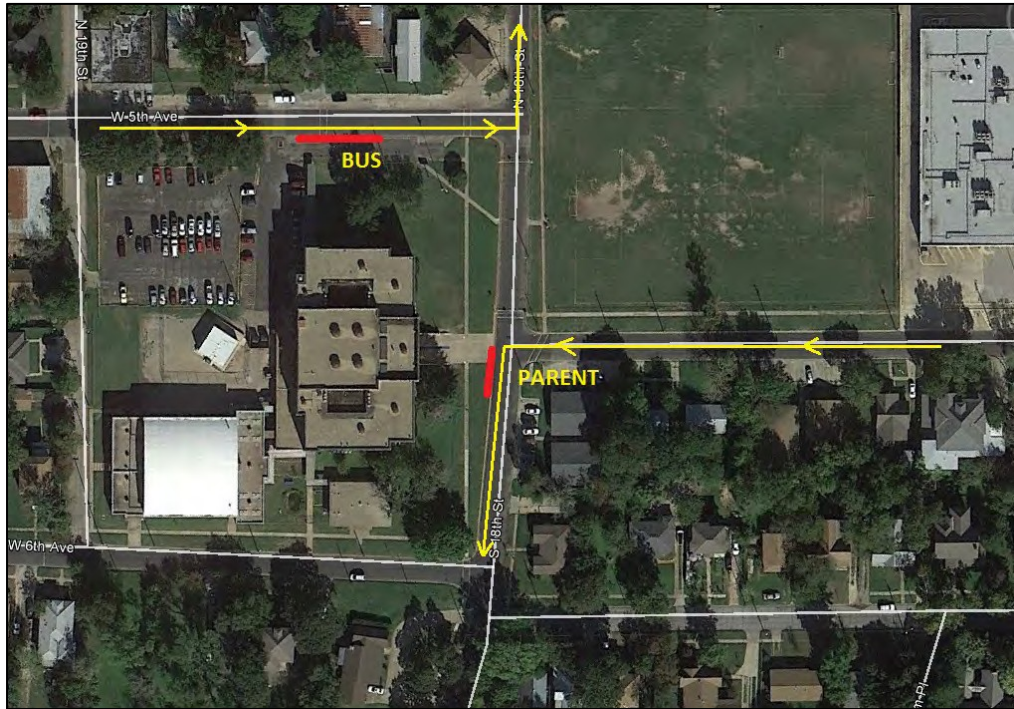
- Canopies should be provided at all student loading areas to provide protection from weather.
- Parent loading for drop-off and pick-up on east side of campus backs up, especially during afternoon pick-up. Afternoon parent and bus pick-up traffic takes approximately 15-30 minutes to disperse. Some parents circumvent the pick-up lines by parking on the streets, and crossing parent and bus lanes to pick-up their children and walk them back; this creates additional safety hazards.

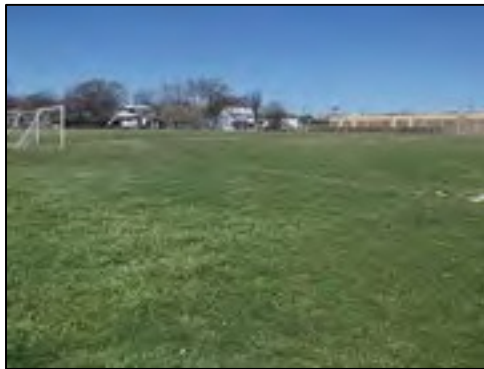
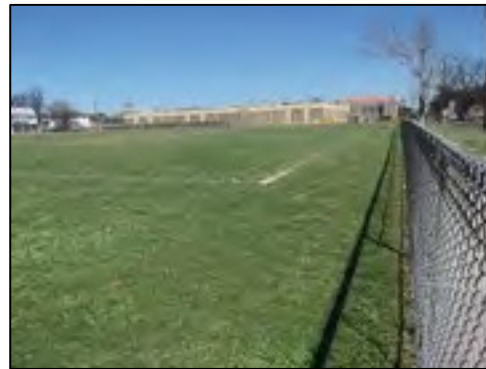
- Playfield is across street; city allows street to be closed during the day to allow safe student passage across street.
- Field crown is poor and does not have good drainage.

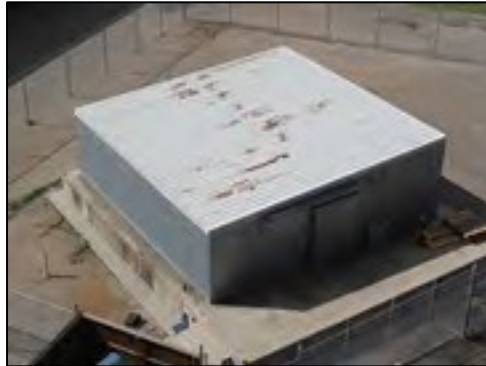
- Walk-in cooler/freezer is located outside of the cafeteria.
