Corsicana High School

General comments, campus capacity, and student demographics

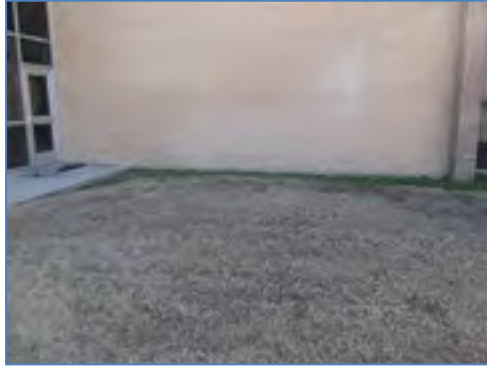
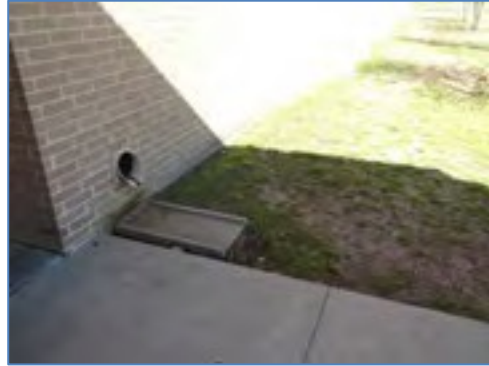
- Ground grade slopes to building instead of away.

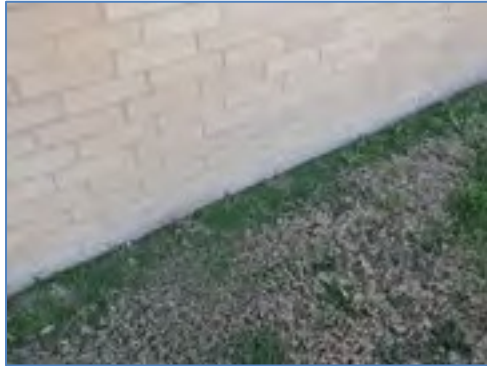
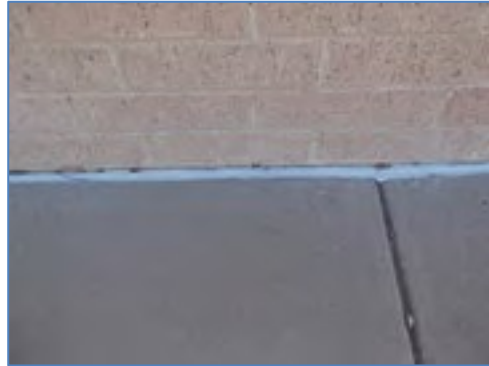
- Brick weep holes are covered by earth and concrete walk.

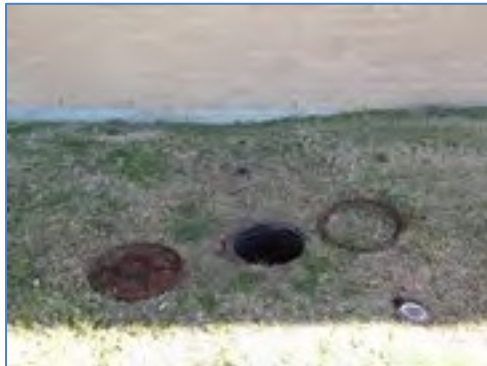
- Open drain presents trip hazard.

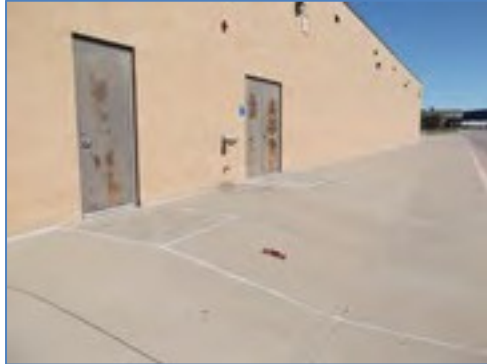
- Doors in B, C, D, and E wing classrooms and in the Vocational building have knobs in lieu of lever hardware.
- Sink pipes and drains are not insulated in boys restrooms in E wing 1st floor and B wing 2nd floor.
- Excessive slope on south side of gym locker rooms, approximately 20%.

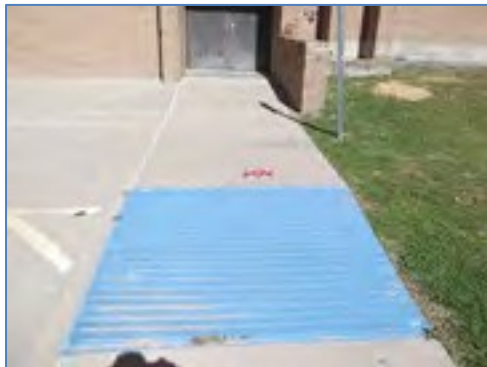
- Sidewalk cross slope is 3.5%, 2% maximum needed.

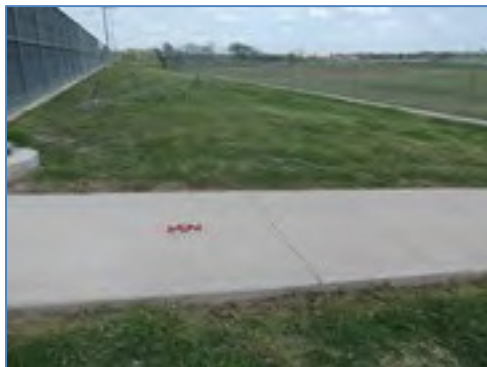
- Sidewalk to practice fields exceeds 5% slope and does not have handrails.

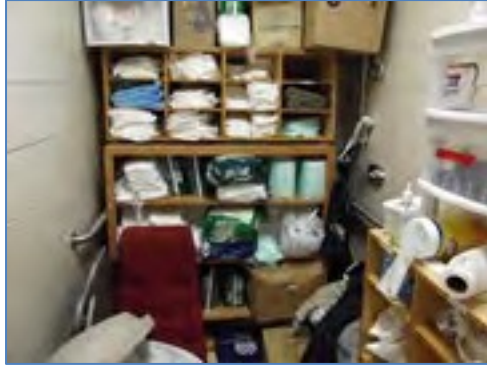
- ADA shower between G103 & G104 is being used for storage.

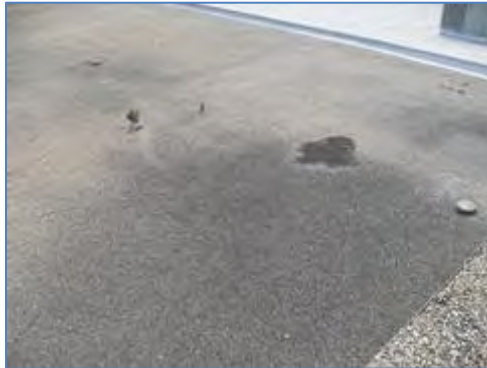
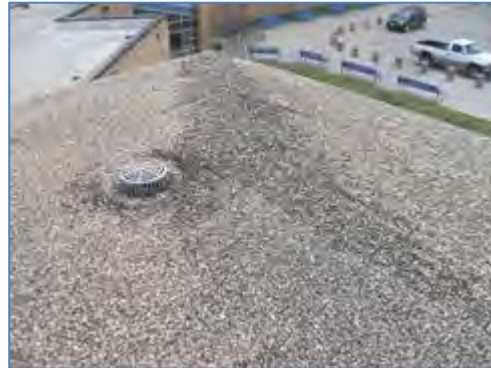
- All roofs are built-up gravel, with the roof on the 2005 addition in good condition and the roofs on the other buildings in good-to-fair condition. Except for the 2005 addition, most roofs are 15 to 20+ years old; these roofs are approaching or have reached the end of their expected life cycle and replacement should be budgeted for in the next five years.
- Minor ponding and gravel loss on roofs.

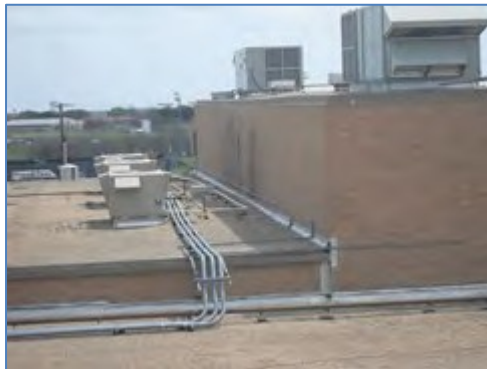
- Cafeteria/auditorium roof seam where leakage may be occurring into ceilings below.

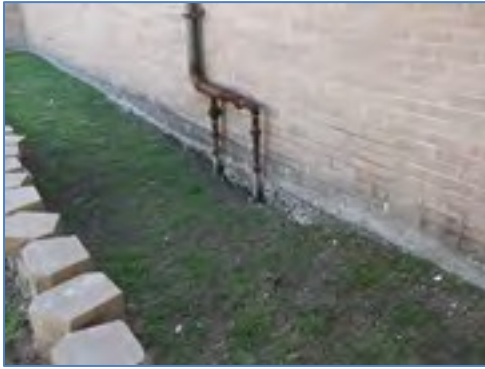
- Recessed area next to Ag building can hold rainwater next to slab.

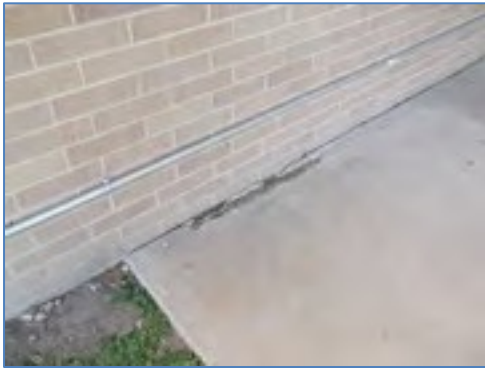
- Exposed rebar near kitchen.

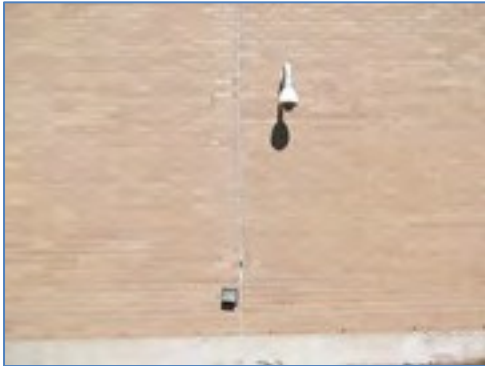
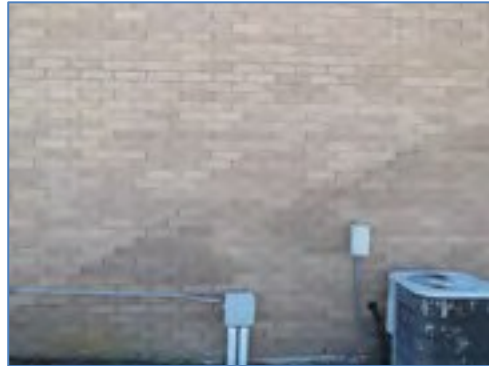
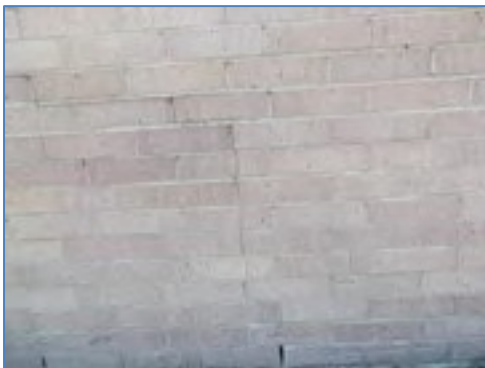
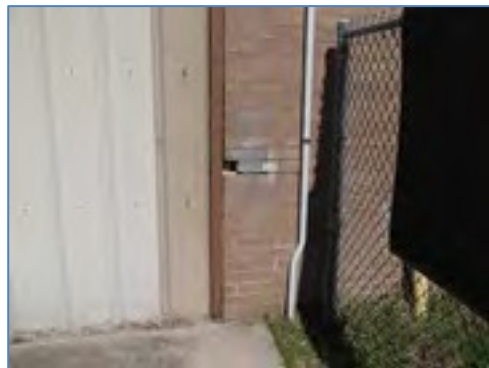
- Minor brick cracks/damage at Main building and Vocational building.

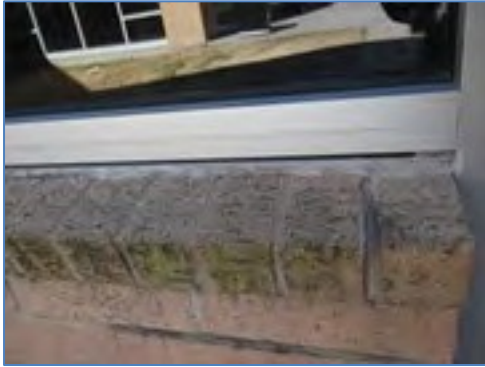
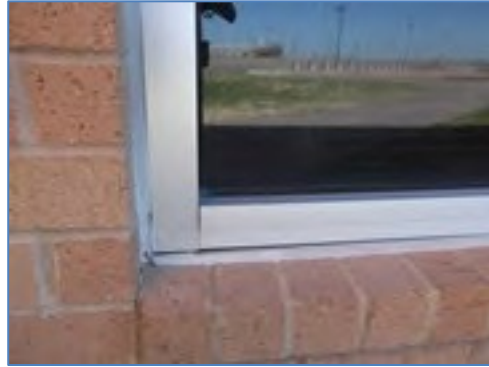
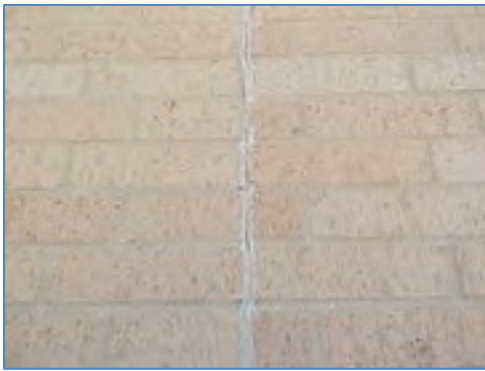
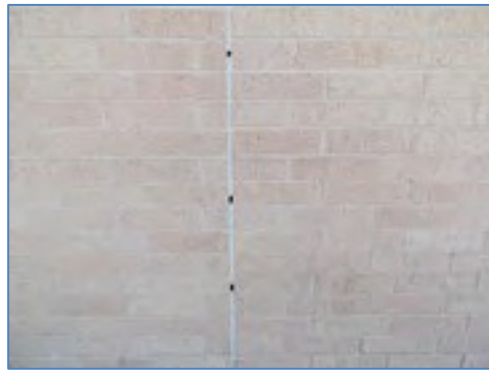
- Most windows are inefficient single pane and caulk and glaze is failing or beginning to fail. Building expansion joint caulk is failing or beginning to fail at all buildings.

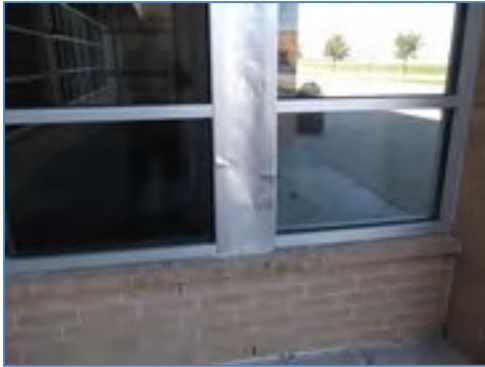
- Damaged window frame trim at new gym entry.

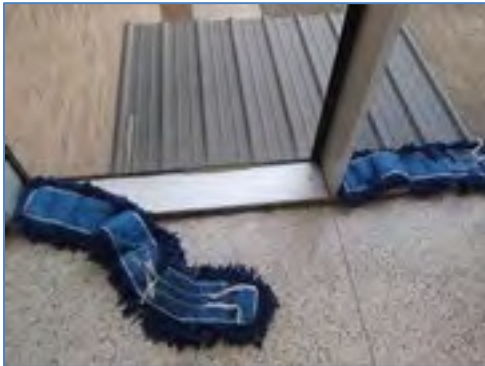
- Condensation or leak occurring, molding is cracked and missing in sections.

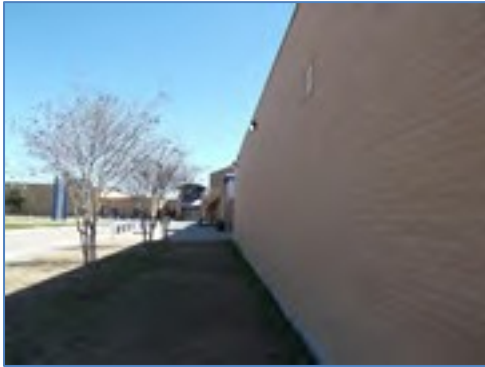
- Security lighting is on during the day.

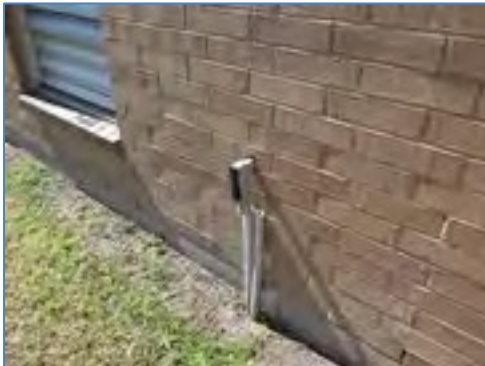
- In many classrooms extension cords are being used for permanent power connections.
- Conduit is pulled apart and box is missing the cover.

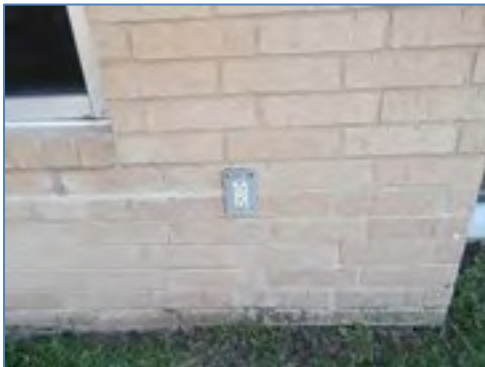
- Missing cover on exterior electrical socket.

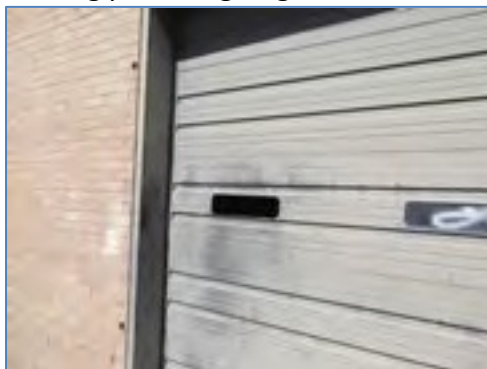
- Most exterior painted finishes are in fair-to-poor condition and are in need of repair and repainting.
- Missing panel in garage door.

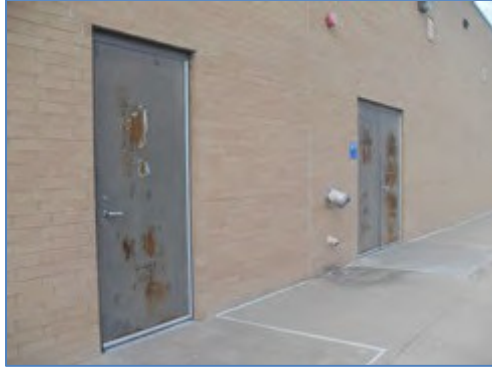
- Rusty doors on south side of gym locker rooms.

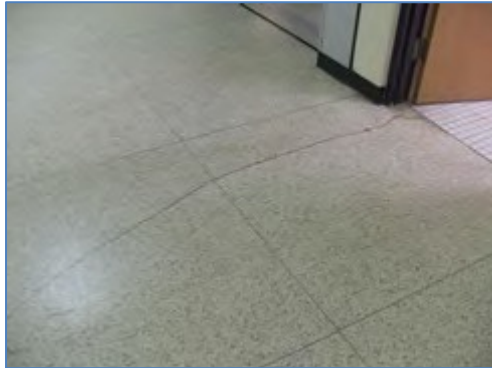
- Carpeting in administrative office area is in fair condition; carpet should be replaced within the next 5 years. When the existing carpet is replaced, it should be replaced with carpet tiles to allow small stained or damaged areas to be replaced without replacing entire areas.
- VCT in Vocational building and in hall behind old gym is in fair-to-poor condition and should be budgeted to be replaced in the next 5 years.
- Terrazzo cracks in B wing hall 1st floor; cracks also observed in other areas.

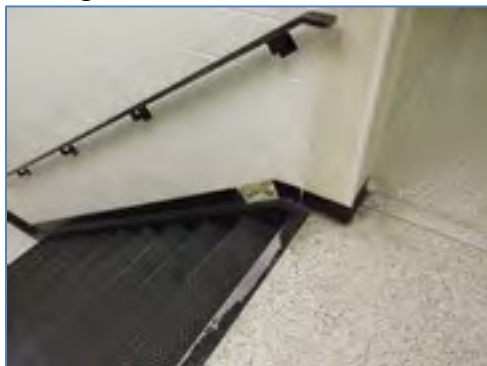
- Damaged stair trim in D hall.

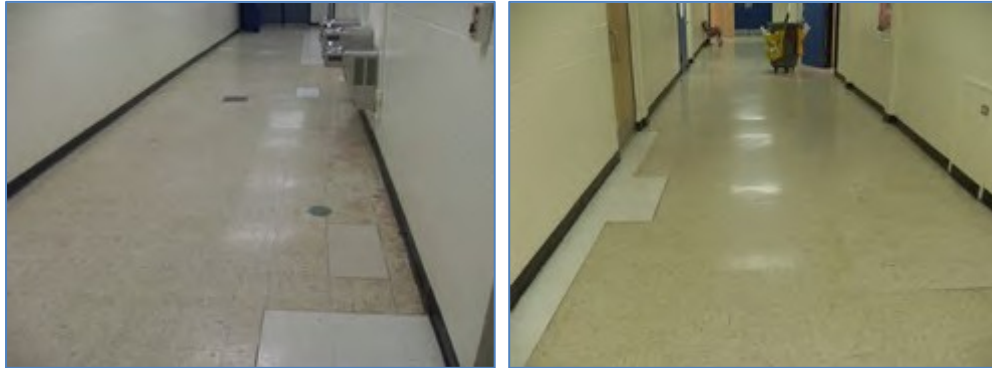
- VCT in fair-to-poor condition in hall behind old gym and in Vocational building.

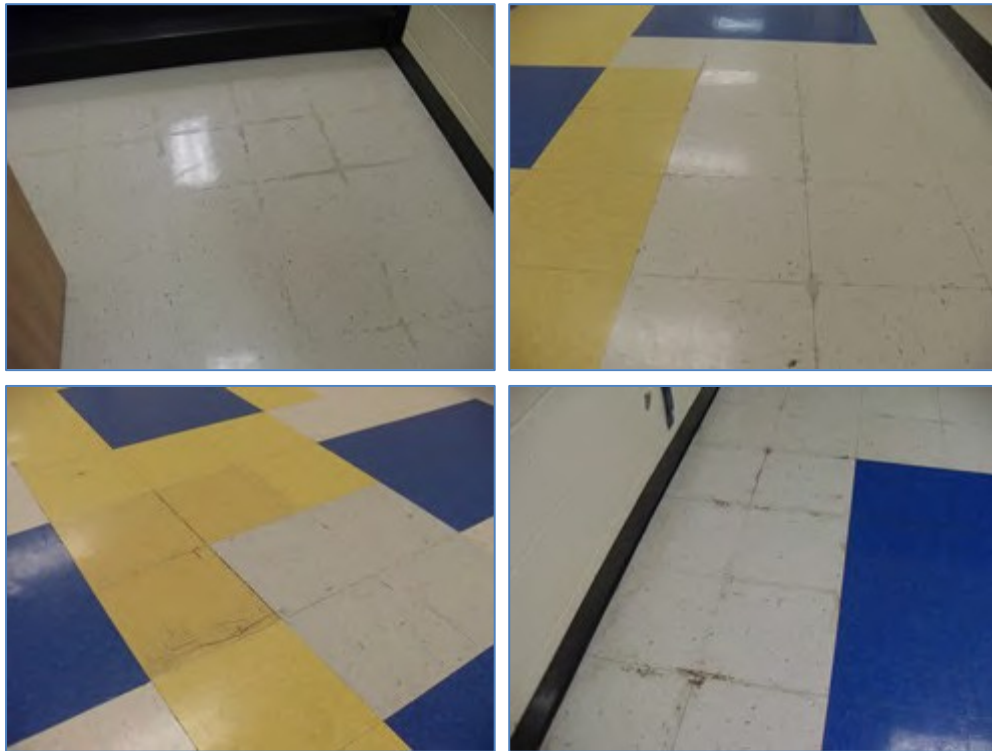
- VCT stains in numerous areas around new gym perimeter: weight room hall, locker room halls, and locker rooms. Moisture may be coming through floor.

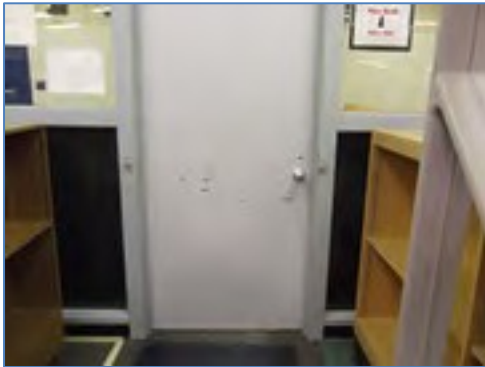
- 2'x4' ceiling tile in all areas except G hall and new gym area is in fair condition and should be replaced within the next 5 years.
- Damaged door finish in library.

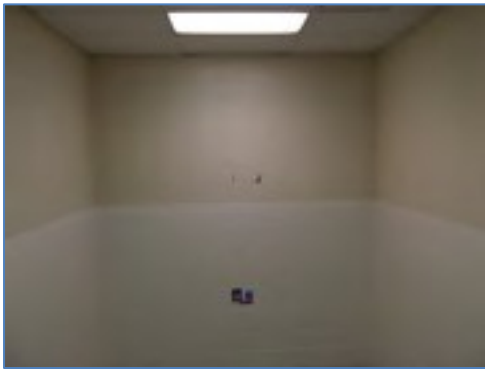
- Poor wall finish in D hall.

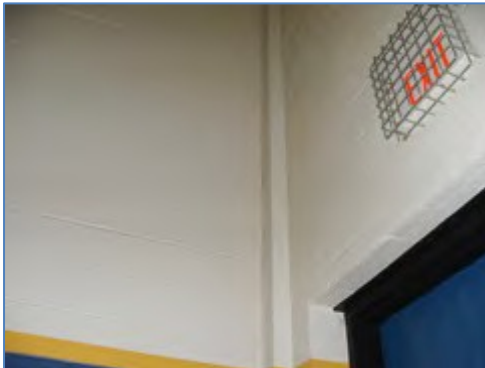
- Corner cracks in old gym need caulking.

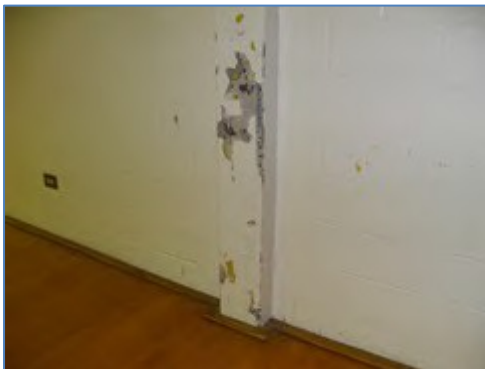
- Surface damage on column in old gym; entire gym needs repainting.

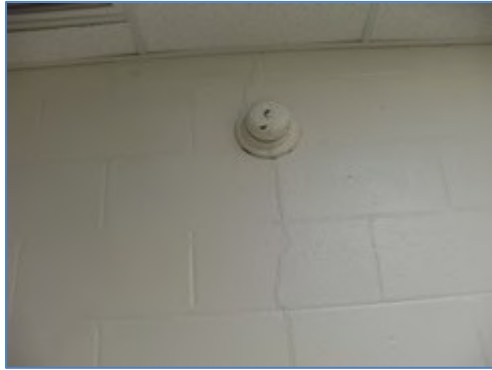
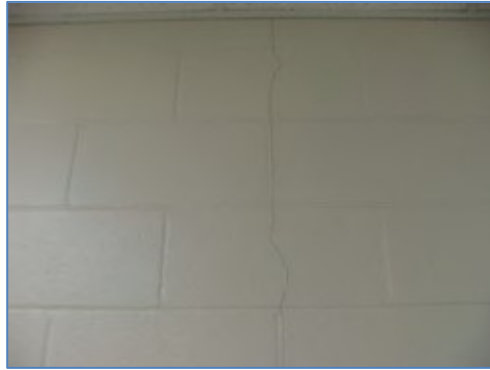
- Wall cracks in hall behind old gym.

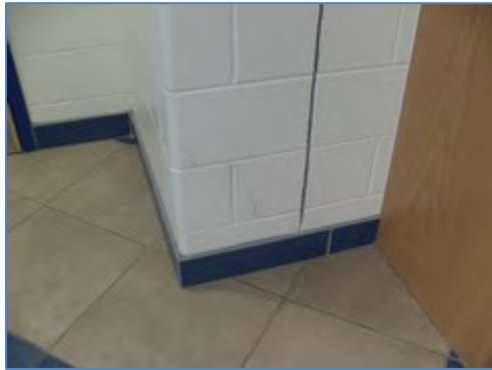
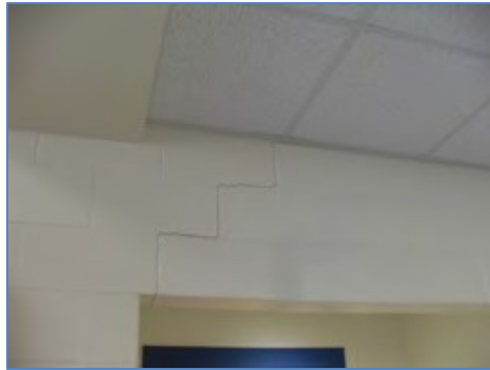
- Wall cracks near girls restroom by new gym.

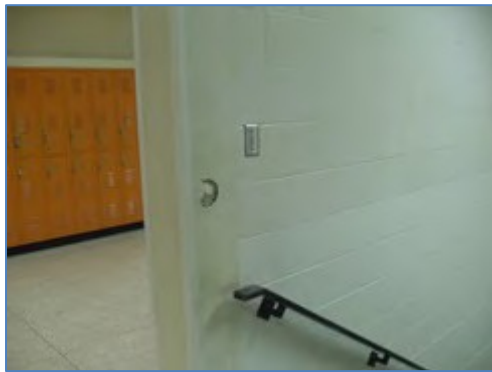
- Hole in wall at 2nd floor C hall near stairwell.

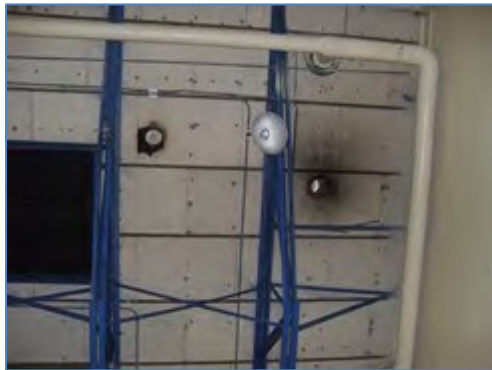
- 2 vents direct to roof through ceiling of old gym (4 locations within gym, 8 vents total).

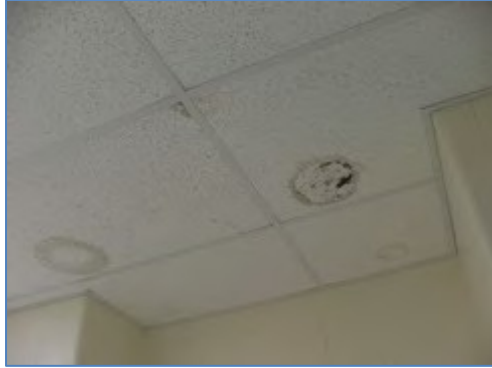
- Moldy ceiling tile in hall to weight room.

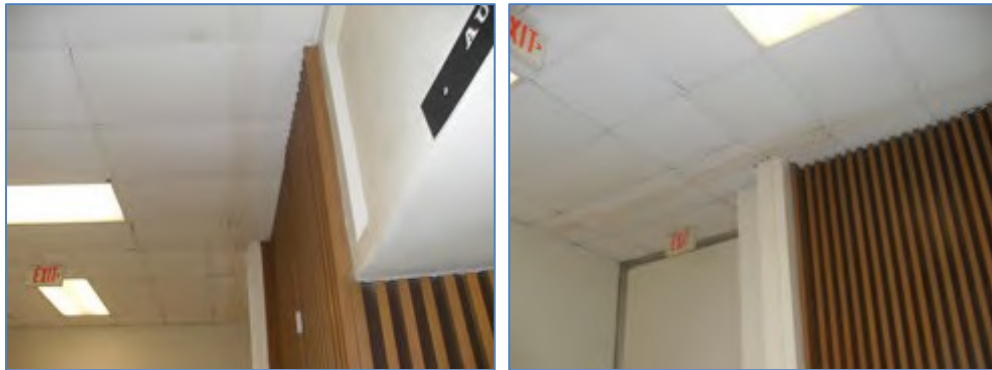
- Long row of stained ceiling tiles in cafeteria outside the auditorium, may be sustained leak from roof seam above.

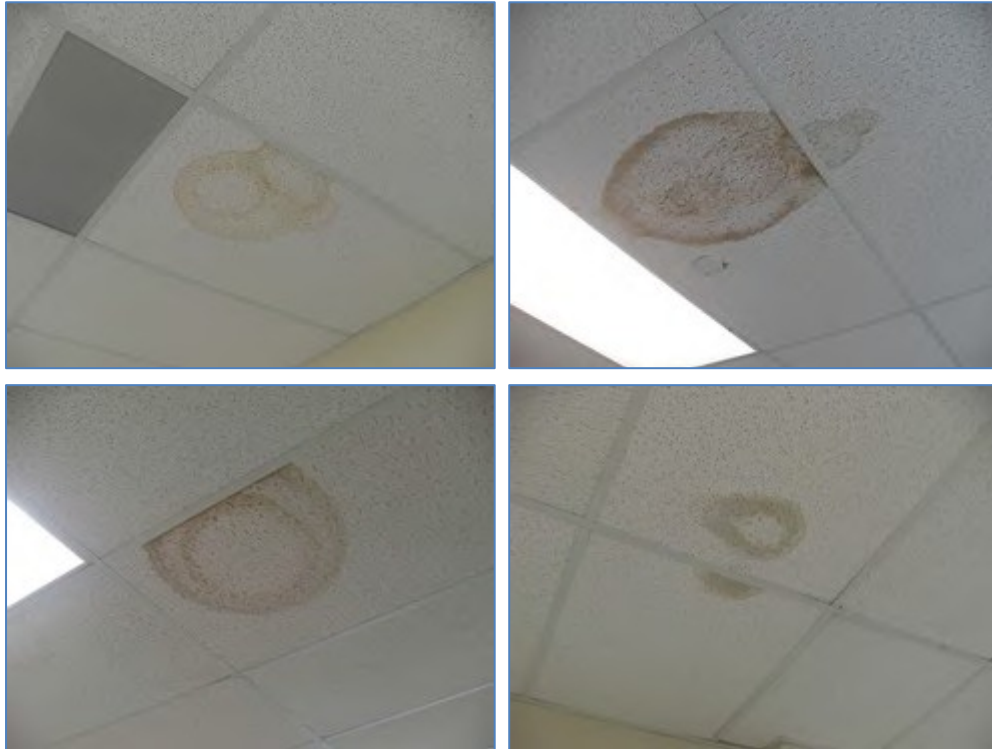
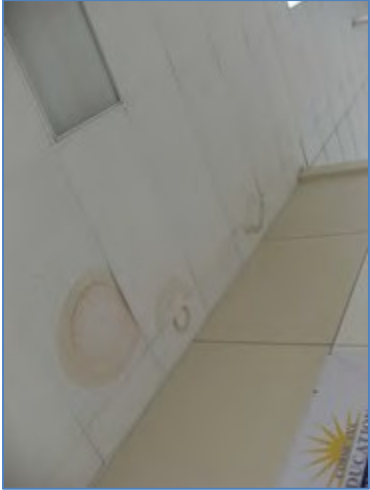
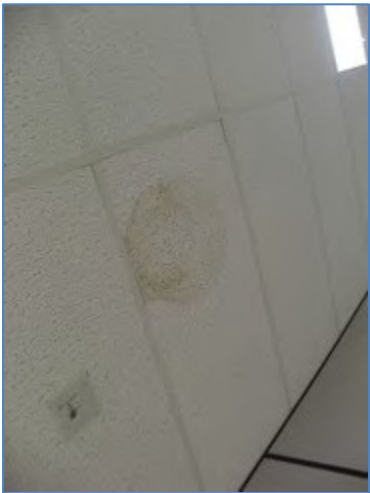
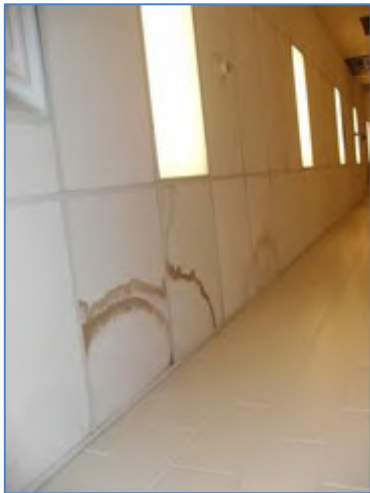
- Stained ceiling tiles in room B-102, G wing hall 2nd floor, 2nd floor long hall, A wing hall 2nd floor, hall near cafeteria, and hall behind old gym.

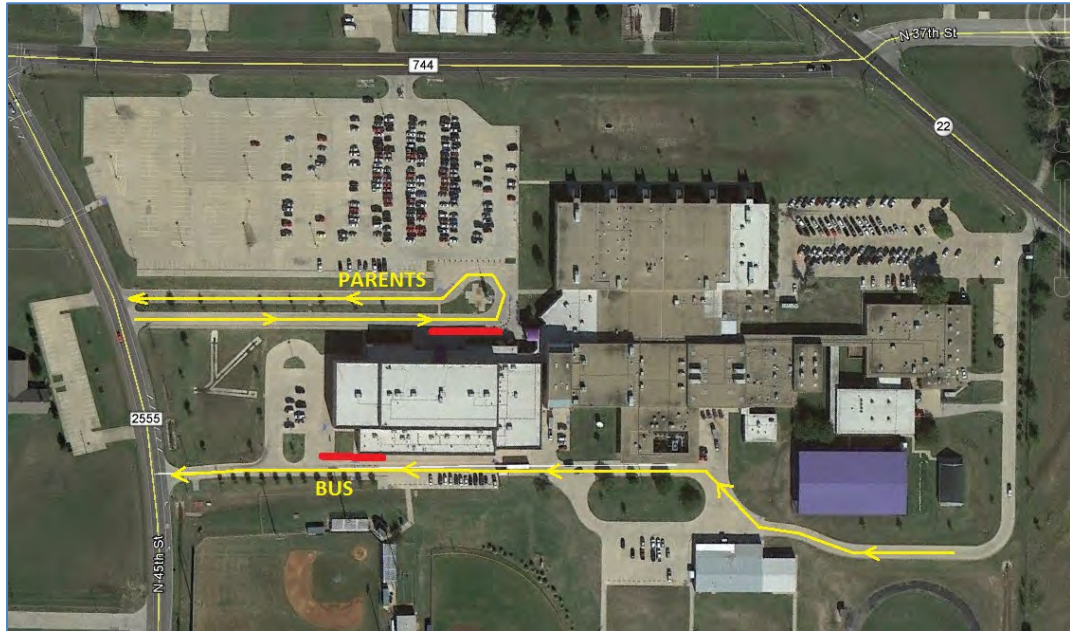
- Canopies should be provided at all student loading areas to provide protection from weather.
- No major problems observed with afternoon parent and bus pick-up.

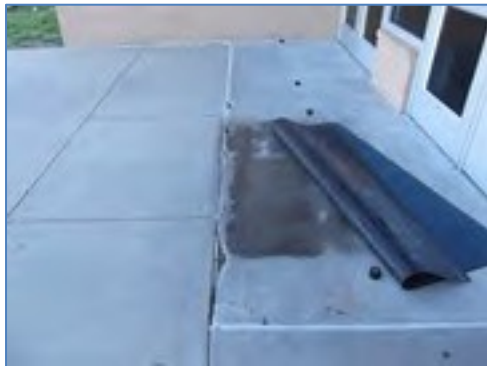
- Cracking concrete landing at entrance to new gym, surrounding concrete is higher than landing.

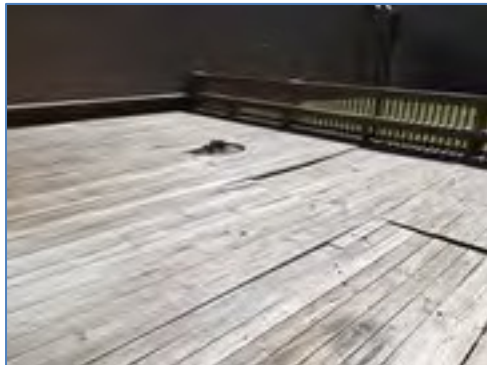
- Weathered deck near Vocational building, structural support may be deteriorating.

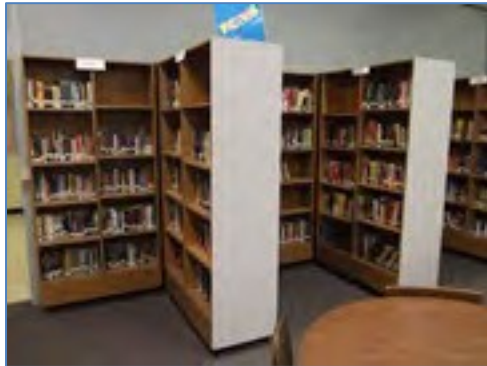
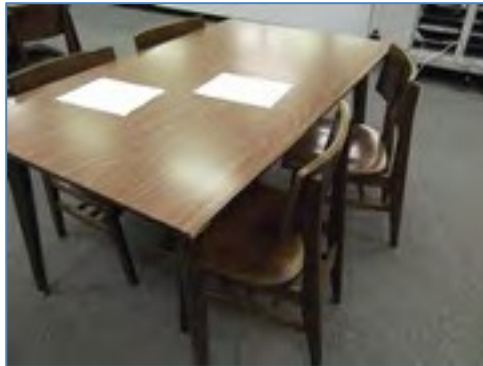
- Some wear observed on library shelving and furniture.
