Sam Houston Elementary

General comments, campus capacity, and student demographics:

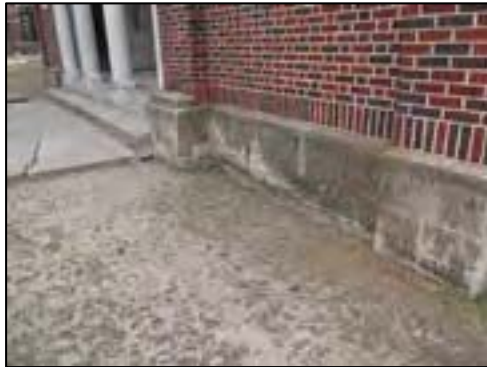
- Grade around buildings should slope away from buildings; in several areas, the grade slopes to the buildings.

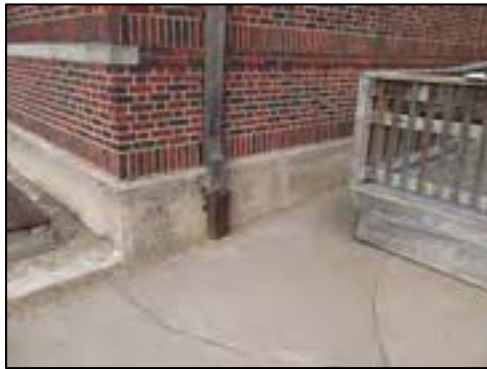
- Concrete slopes to building and storm drain is filled with gravel.

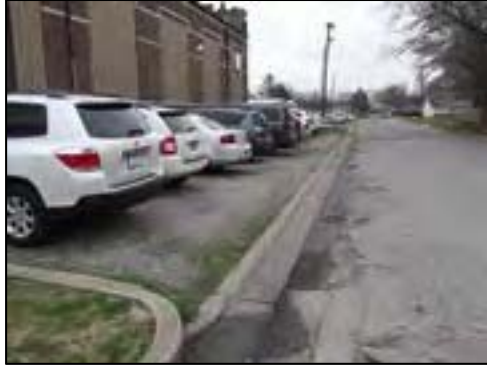
- Gravel surface at west parking.

- Recommend rebuilding the west parking to provide an asphalt surface, and seal coating the asphalt surfaces at the east and northeast parking within the next 2 years.

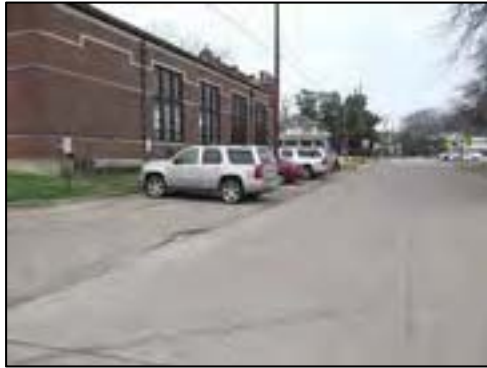
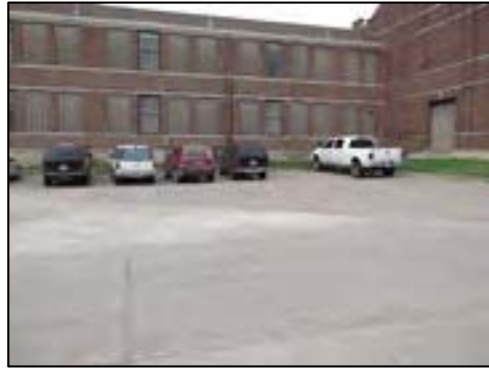
- Asphalt surface at east parking.

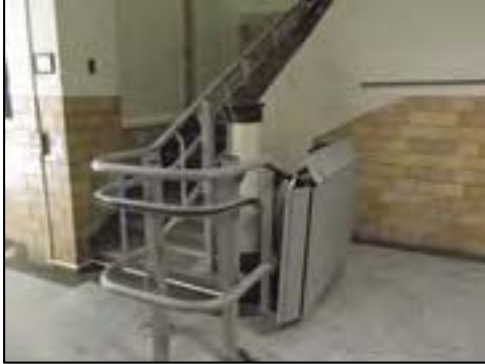
- Many doors have pull handles in lieu of lever hardware.
- No ADA restrooms provided for staff; no sinks in student restrooms are completely ADA accessible.
- Wheelchair lift provides access to 2nd floor; access by elevator is recommended.

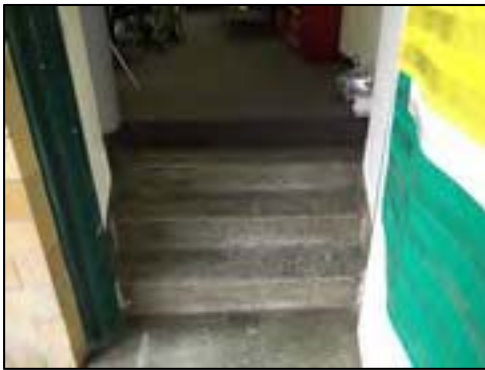
- Steps prevent wheelchair access into the Music/Art room.

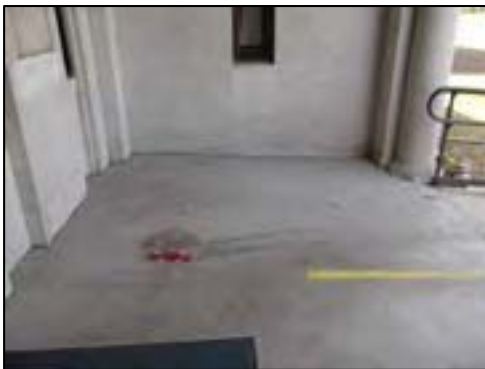
- Landing at top of ramp at main entrance has excessive slope, 2% maximum needed.

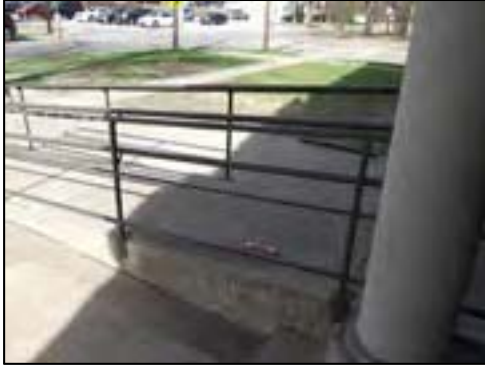
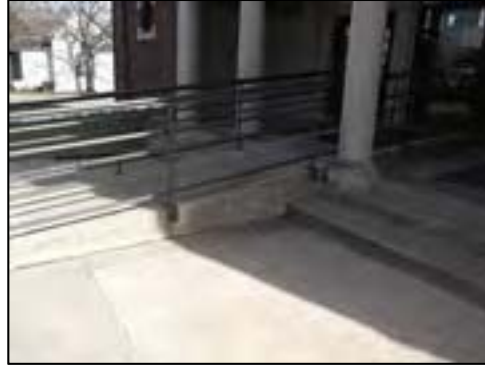
- Ramp to auditorium has excessive slope, 8.3% maximum needed.

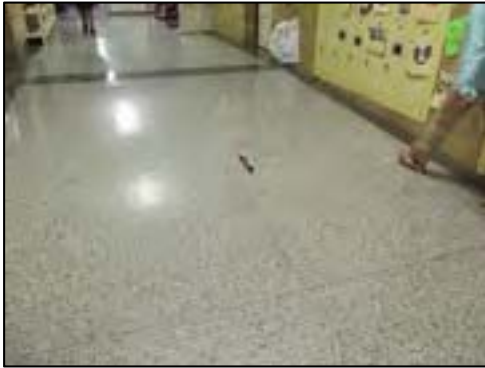
- Handrails needed at ramp in hallway of Main building.

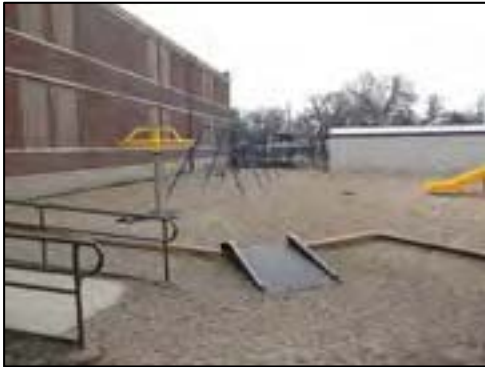
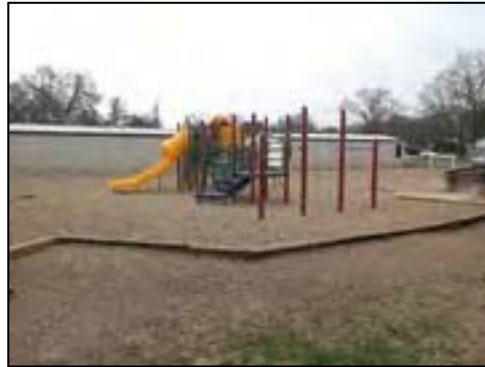
- ADA access provided to edge of playground, but no access to equipment.

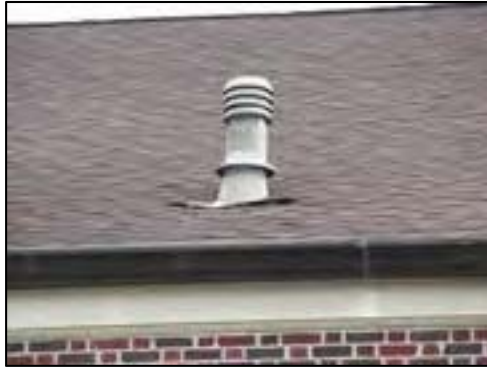
- Flashing on vent is rolling up.

- Roof on the Main building is asphalt shingle and the Cafeteria roof is built-up gravel. The roofs are 20+ years old and are in fair-to-poor condition; the roofs have reached the end of their expected life cycle and replacement should be budgeted for in the next five years.

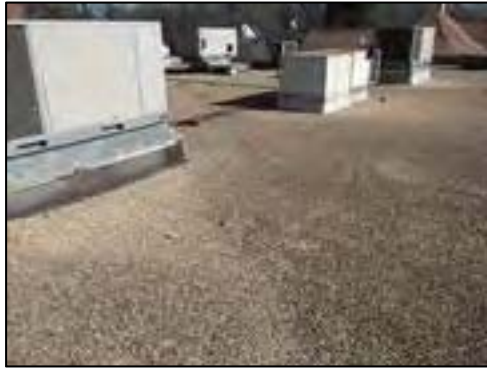
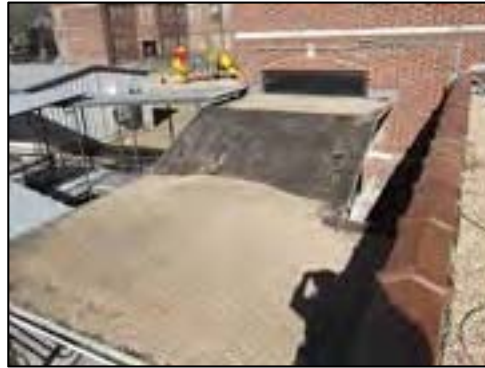
- Typical Cafeteria building roof conditions; staff reported leak in Cafeteria.

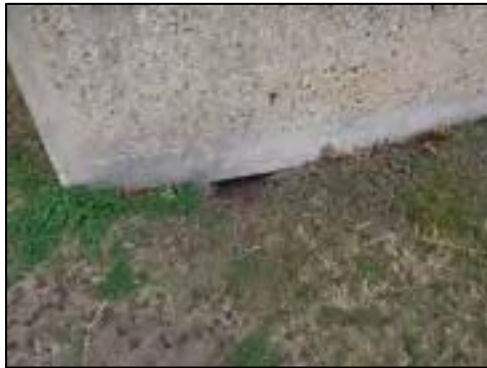
- Opening under slab at corner of gym.

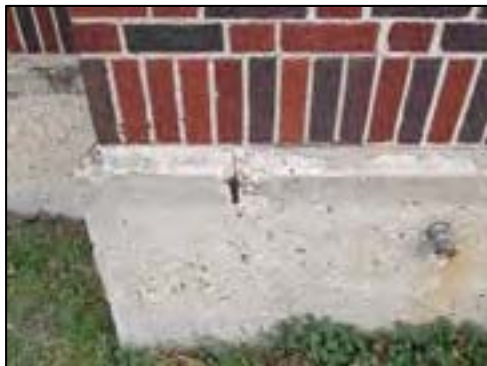
- Exposed rebar in slab.

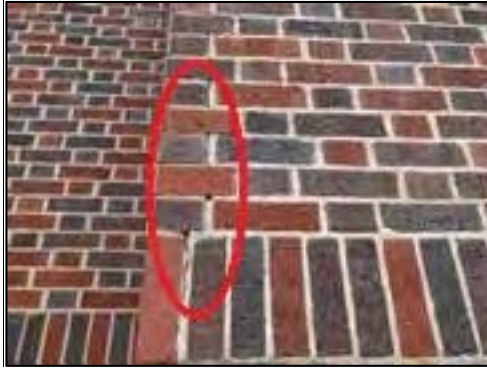
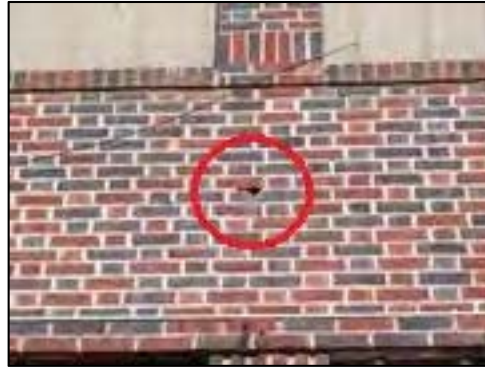
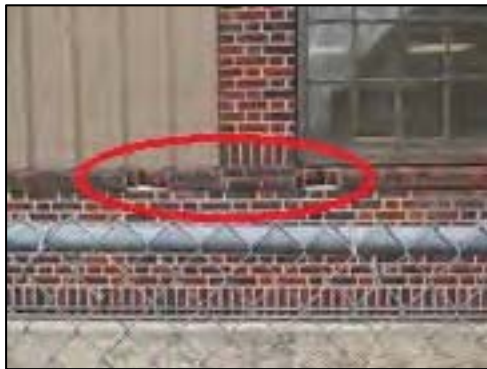
- Various brick cracks and brick damage around building.

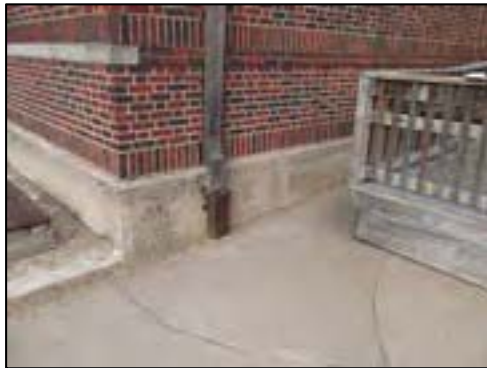
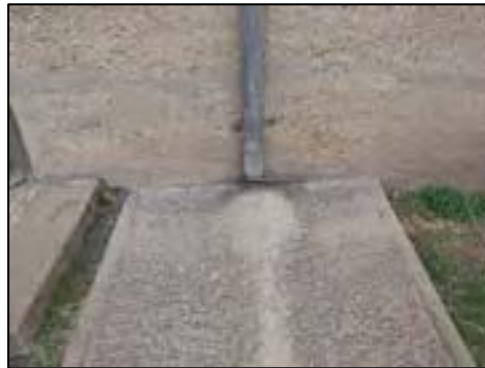
- Damaged downspouts in several locations.

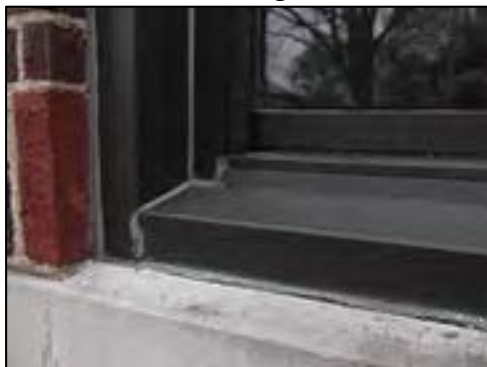
- Windows in Main buildings except east side are inefficient single pane and caulk and glaze is failing. Building expansion joint caulk is failing or beginning to fail at Main and Cafeteria buildings.

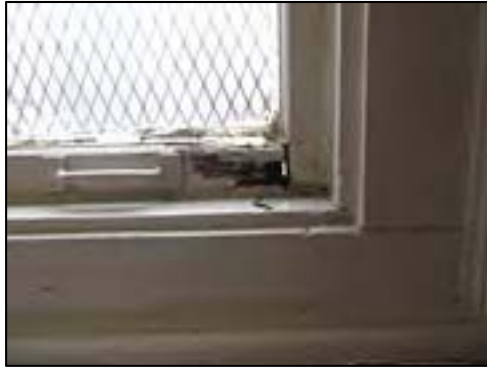
- Wood window is rotting.

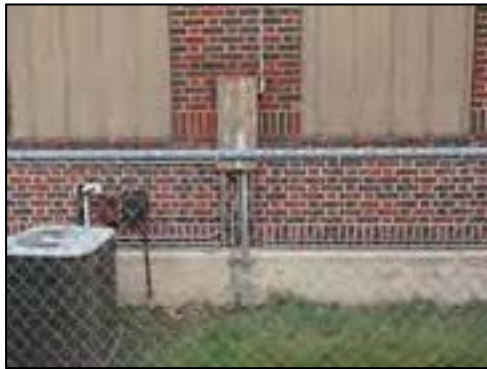
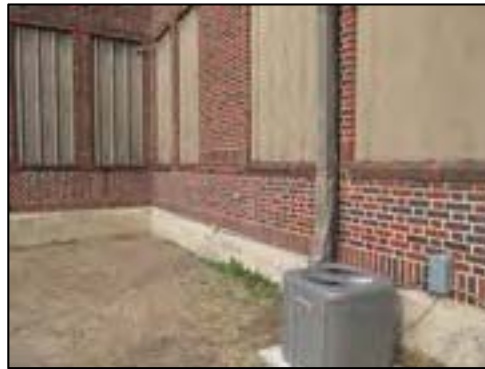
- In many classrooms extension cords are being used for permanent power connections.
- Exposed exterior data cable should be placed inside conduit for better protection.
- Survey reported breakers tripping in teachers' lounge A113.
- Exposed electrical conduit.

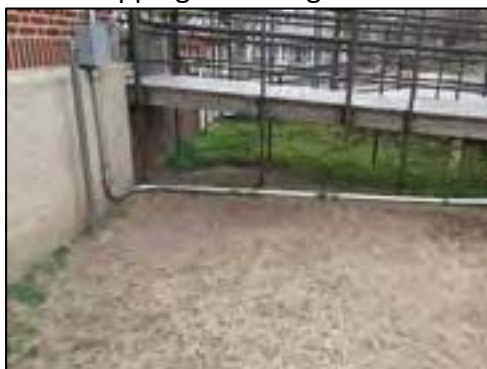
- EMT strapping is missing and conduit is on the ground.

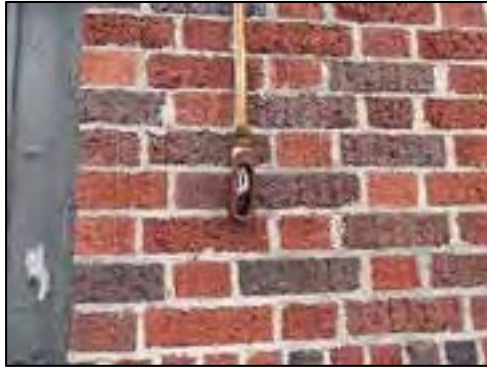
- Exterior electrical cover missing allowing wires to be exposed.

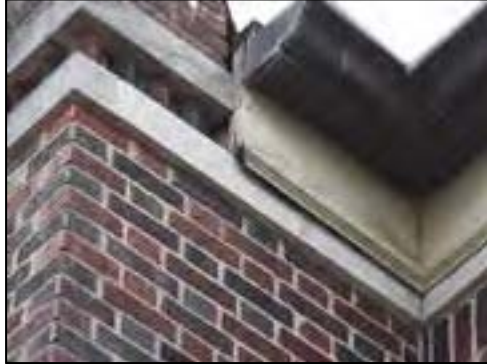
- Most exterior painted finishes at all buildings are in fair-to-poor condition and are in need of repair and repainting.
- Fascia trim is detaching.

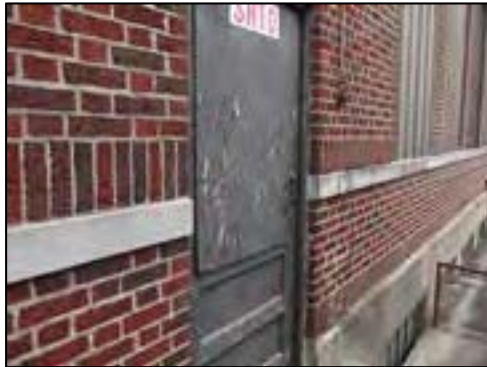
- External wood door is in poor condition.

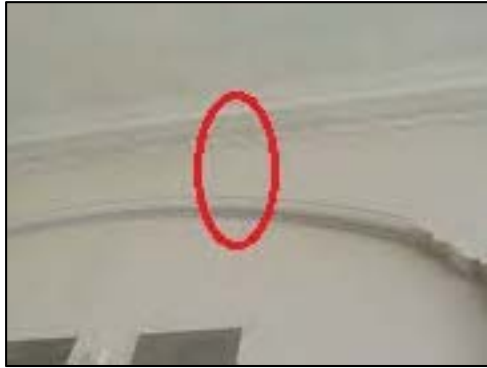
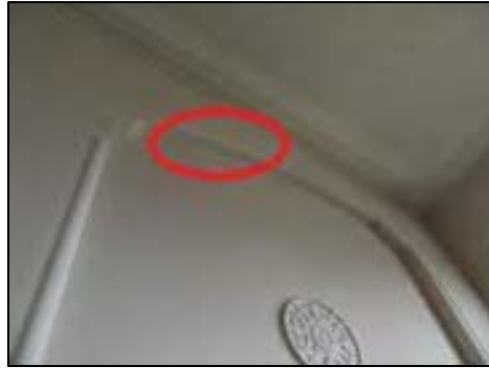
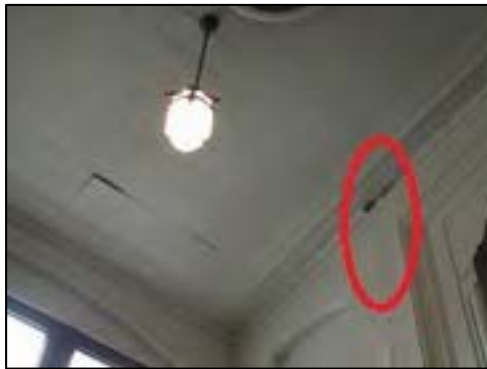
- Cracked walls in auditorium.

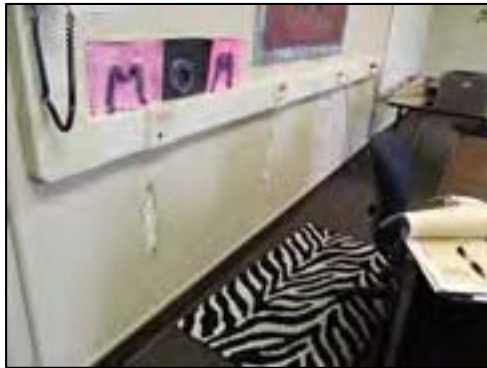
- Damaged wall in room B107.

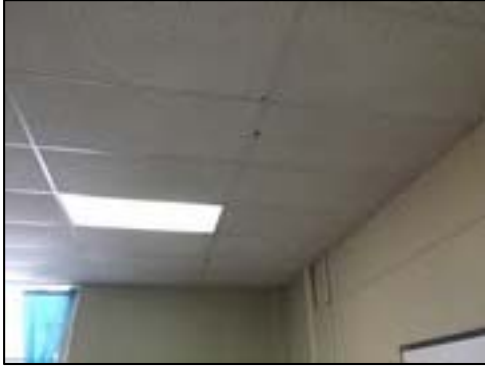
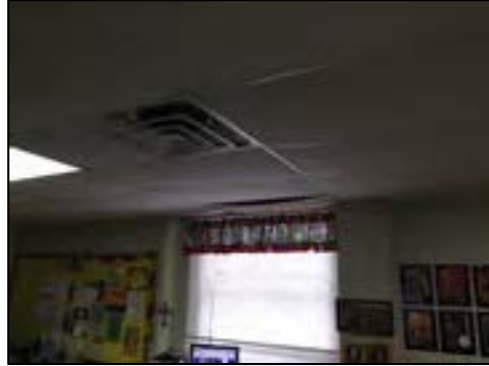
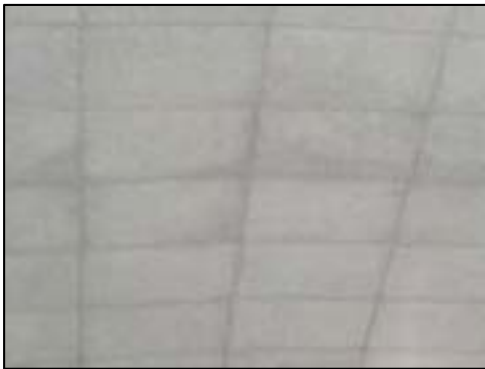
- Damaged, sagging, and stained ceiling tiles in B107, A101, and gym.

- Interior painted surfaces are in fair-to-poor condition in all buildings; interior surfaces should be repainted in the next 3 years.
- 2'x4' ceiling tile in all buildings is in fair-to-poor condition and should be replaced within the next 5 years.

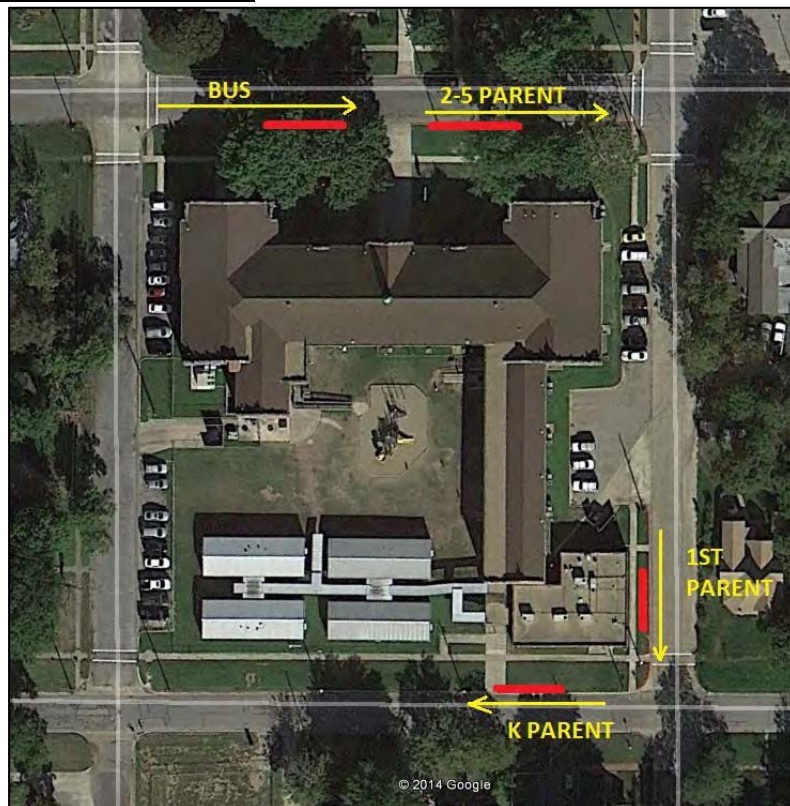
- Canopies should be provided at all student loading areas to provide protection from weather.
- Parent loading for drop-off and pick-up on north, east, and south sides of campus backs up, especially during afternoon pick-up. Afternoon parent and bus pick-up traffic takes approximately 10-15 minutes to disperse. Some parents circumvent the pick-up lines by parking on the streets, and crossing parent and bus lanes to pick-up their children and walk them back; this creates additional safety hazards.

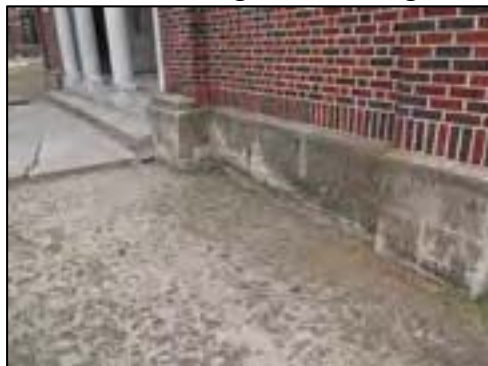
- Sidewalk is settling and cracking, with gap forming under step.

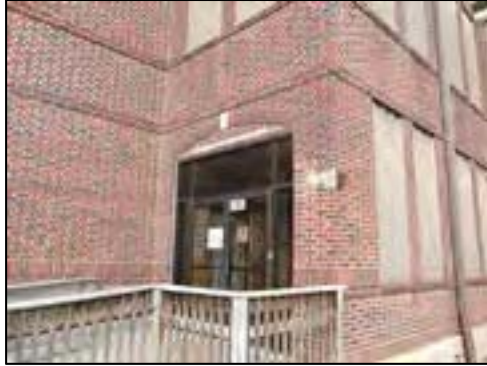
- No canopy over door through which K-1st dismisses.

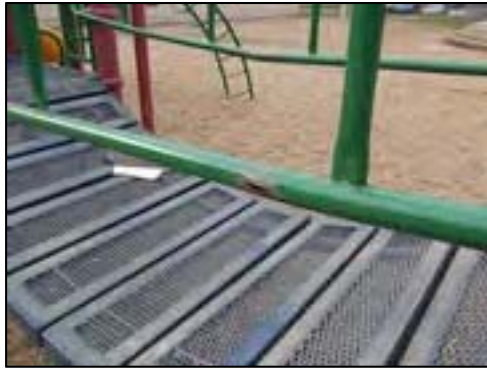
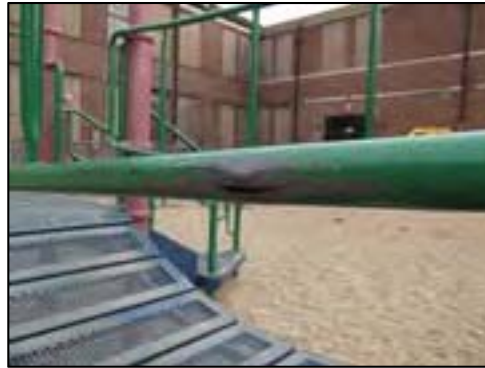
- Split pipe on rail of playground equipment.

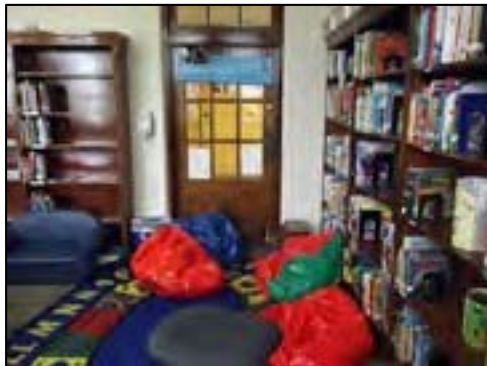
- The campus does not have adequate emergency lights for safe egress.
- Recommend addition of strobes, pull stations, and additional smoke detectors to the fire alarm system.
- Portable building had fire pull box pulled out of wall and fire pulls were not connected.
- Blocked exit in library.
